ALIANO (MATERA - ITALY)

Completion of Agri - Sauro hydraulic tunnel.

October 98 – November 01

Irrigation Authority for the Puglia, Lucania and Irpinia districts (Bari).

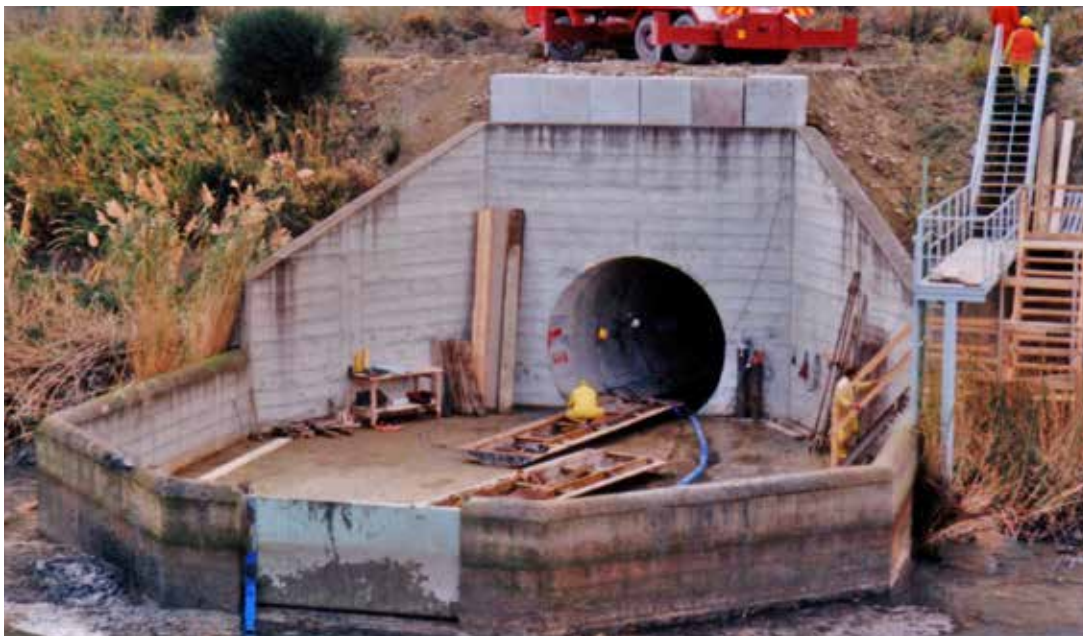
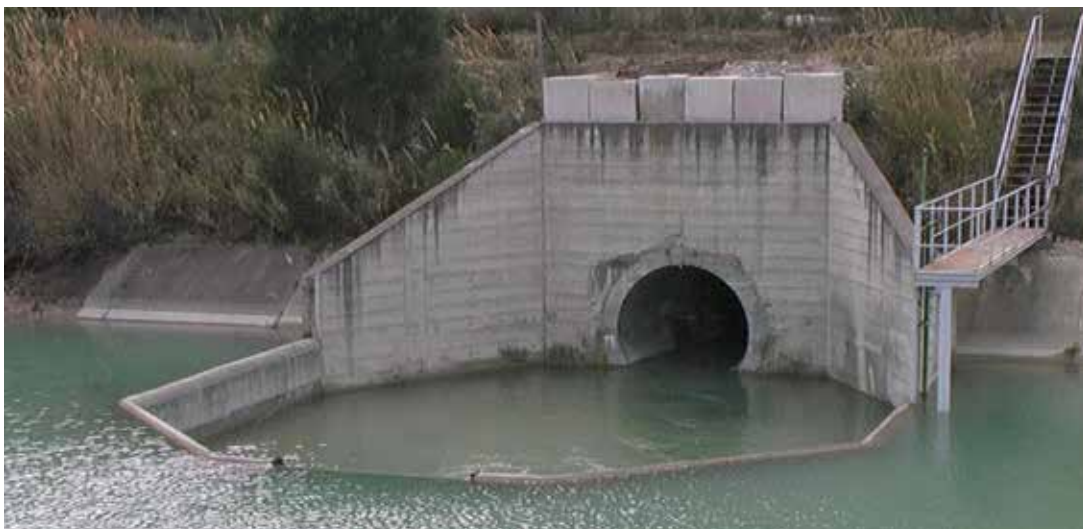
Fig. 1 - 2. Tunnel entrance from the side of the Sauro river during works (above) and after completion (underneath).

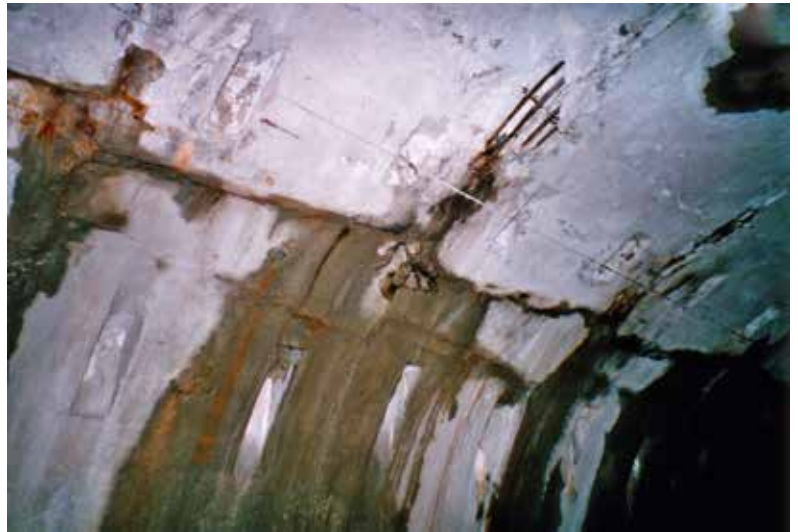
The tunnel, 6615 lin.mt. long with an internal diameter of 3.5 m. is covered with pre-fabricated slabs and was completed in February 1991. It was never possible to use it because of damage inside and several sites of breakage of the slabs (Fig. 3).

Fig. 3. Fissuring of slabs and water infiltrations.

to identify the constant presence of levels of sand, saturated with water, in the layers of clay silt and silty clay that had a strong thrusting action; the review of the project made a further works necessary to place the tunnel in safe conditions by installing a new covering that could counter the thrust generated by the rock mass and make the structure functional.

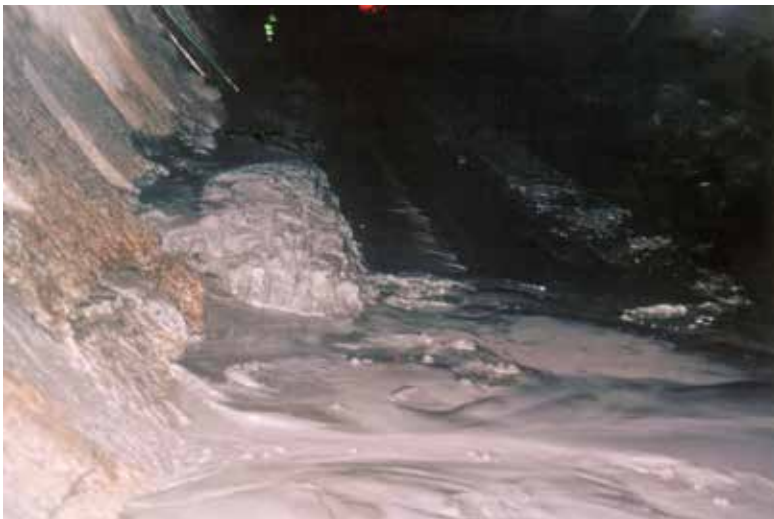
Also, in long sections of the tunnel, there were numerous infiltrations of water and silty sand, particularly at position 3450, where hundreds of cubic meters of material accumulated on the bottom (Fig. 4). This narrowed the gauge of the tunnel and damaged the covering slabs further. Following inspection of the geo-lithological conditions of the rock mass, it was possible

Fig. 4. Accumulations of material along the tunnel.

The main works were preceded by a complete cleaning of the tunnel (removal of the material accumulated on the floor, washing of the slabs and restoration of the tracks).

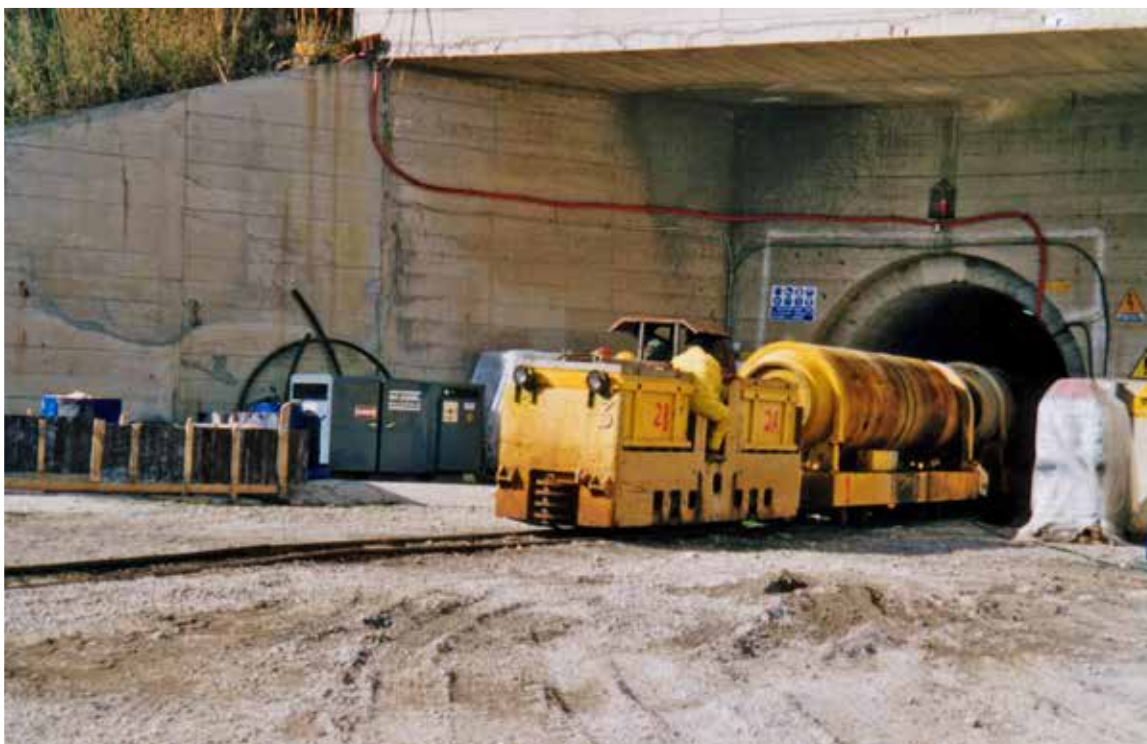
Fig. 5. Movement of the concrete in the tunnel for pouring.

The final lining was installed by 60 m sections as works progressed, with pourings of fiber and steel-reinforced concrete, prepared outside and conveyed into the pouring zone by Beton trains (fig. 5), using modular hydraulic formworks (60 m long with an external diameter of 2.80 m) (fig. 6-7).

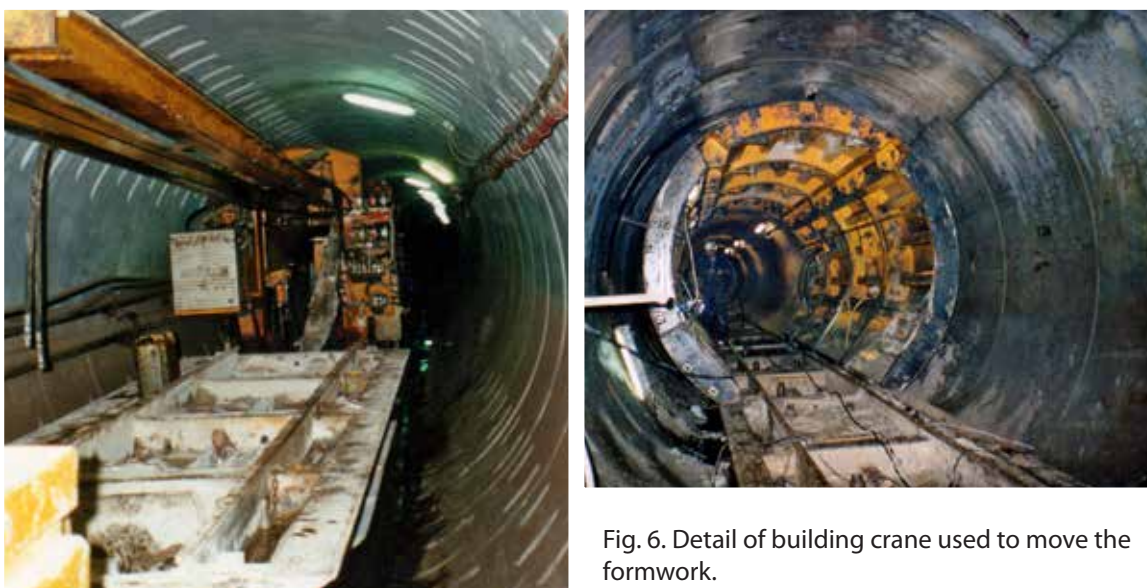
Fig. 6. Detail of building crane used to move the formwork.

Fig. 7. Pouring stage seen from inside the formwork.

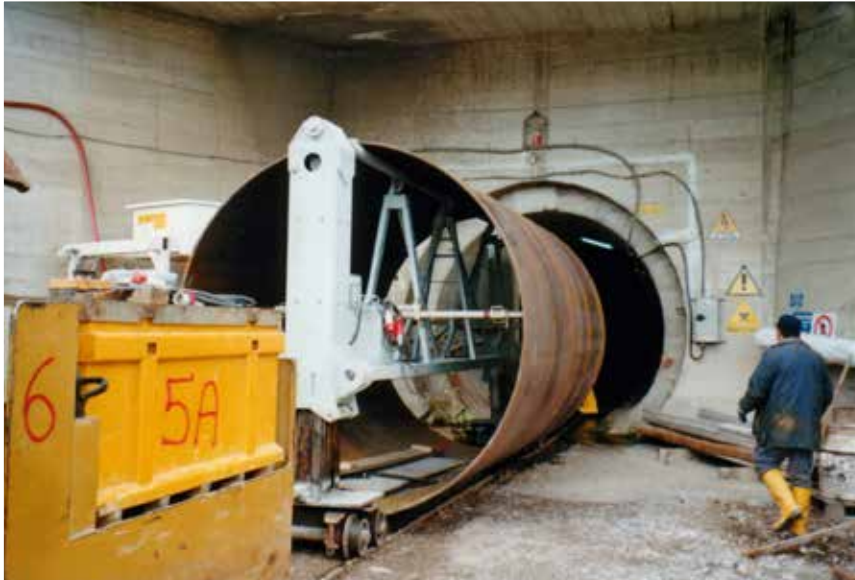
Fig. 8. Movement of the pipe into the tunnel.

At the more severely damaged points, where the structural collapse was most accentuated, the concrete covering was poured after installing a steel pipe, adherent to the slabs, designed for radial perforations and subsequent injections of cement to consolidate the treated zone.

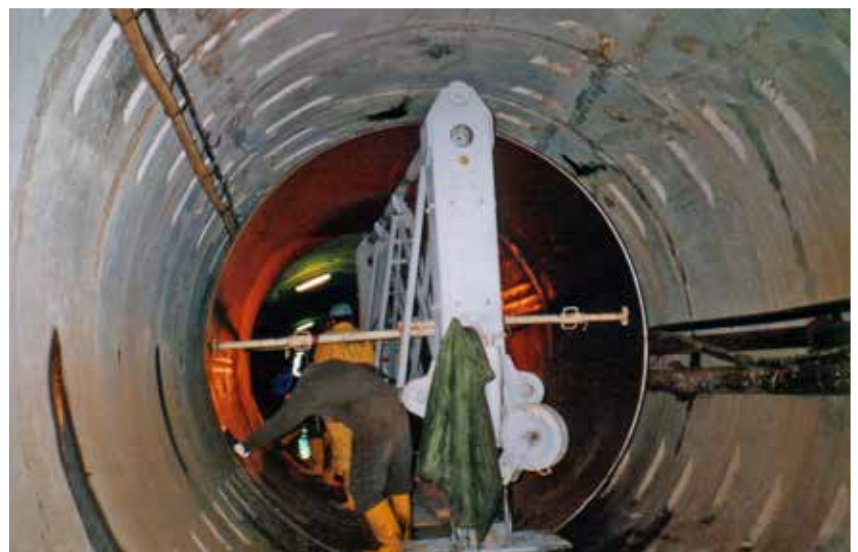
Fig. 9. Installation of pipe in the tunnel and injection.

The juncture between two adjacent sections of pouring was further waterproofed with the injection of foam resin and sealing of the joint after milling it (Fig. 9). The new covering of the tunnel was also waterproofed with a treatment involving osmotic penetration (Fig. 9).

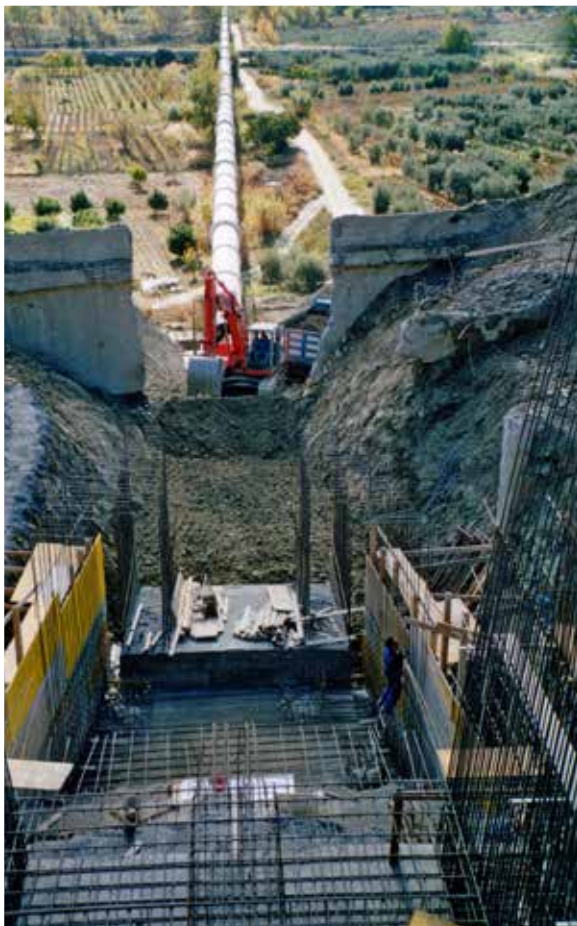
Fig. 11. Construction of the tank.

After completing the covering, a tank in reinforced concrete was built at the entrance to the tunnel on the Agri river side, which would convey the waters from the Sauro into the bed of the Agri river (Fig. 11 - 12).

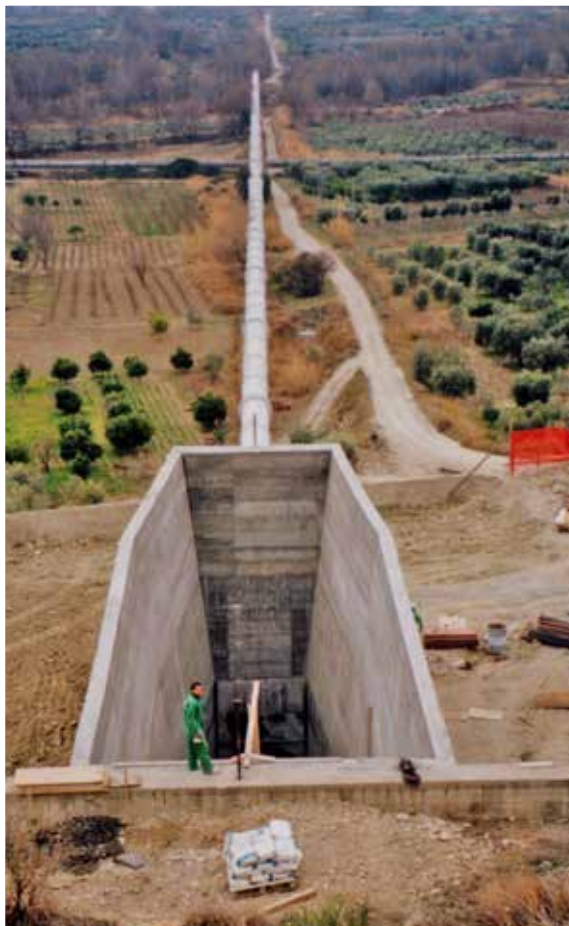
Fig. 12. Completed tank.
