## SABADELL (BARCELONA - SPAIN)

Consolidation of the structural wall along the "Ronda de Santa Maria" road.

April – July 2001

Municipality of Sabadell

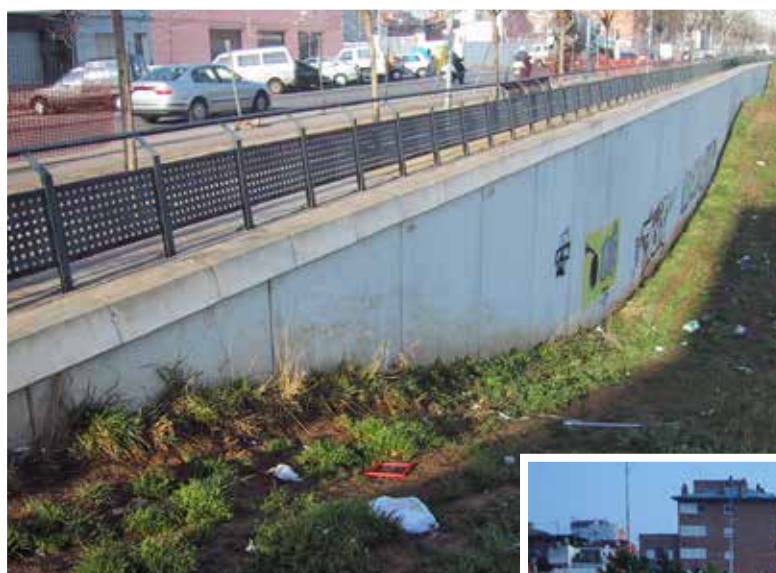
Fig. 1. View of the wall before the works.

The works included construction of a structural retaining wall for elevation of the road, with a length of about 105 m, consisting of prefabricated panels fastened to a crossbar in reinforced concrete. A year after completion of the works the paving broke and sank and the wall showed signs of rotation and cracking of some of the panels. This forced the Authorities to close two of the four lanes and undertake geotechnical studies, which gave the following results:

- a the wall foundation soil consisted of silty clay, with geotechnical characteristics of very poor quality;
- a the foundation materials for the new road bed were of extremely poor quality, consisting of clay, masonry waste, plastic material, etc.;
- a the drainage system was insufficient.

It was therefore decided to undertake works to consolidate and restore the structure, proceeding in two operating stages:

- a removal of the foundation soil of the roadbed to the level of the crossbar in the wall, and replacement with appropriately selected sandy materia;
- a consolidation of the wall foundation soil and strengthening of its structure.

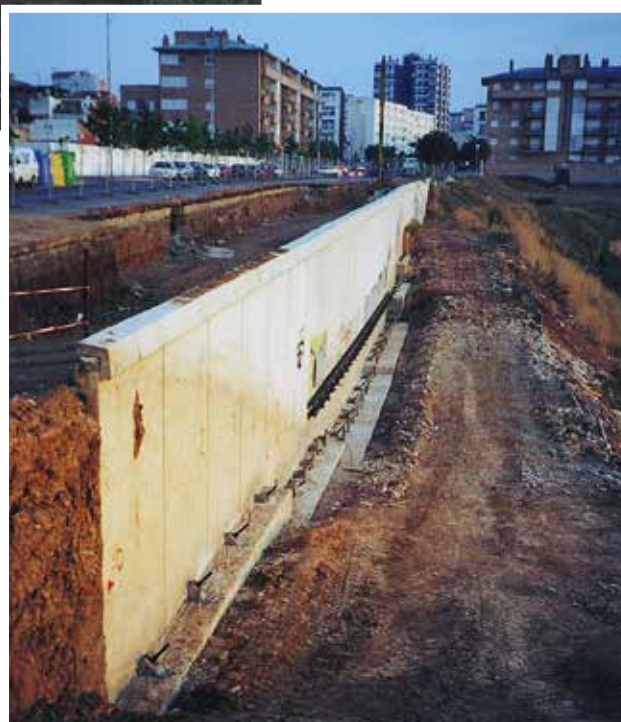
Fig. 2. View of the consolidated wall.

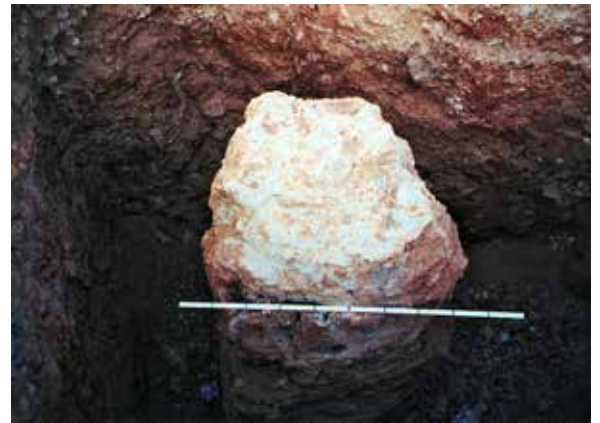
Fig. 3. Test field column.

The works of consolidation were carried out using **Pacchiosi Jet Grouting System 1 (PS1)**, tested with the performance of a field trial (Fig. 3) to optimize the injection parameters relative to the soils to be treated.

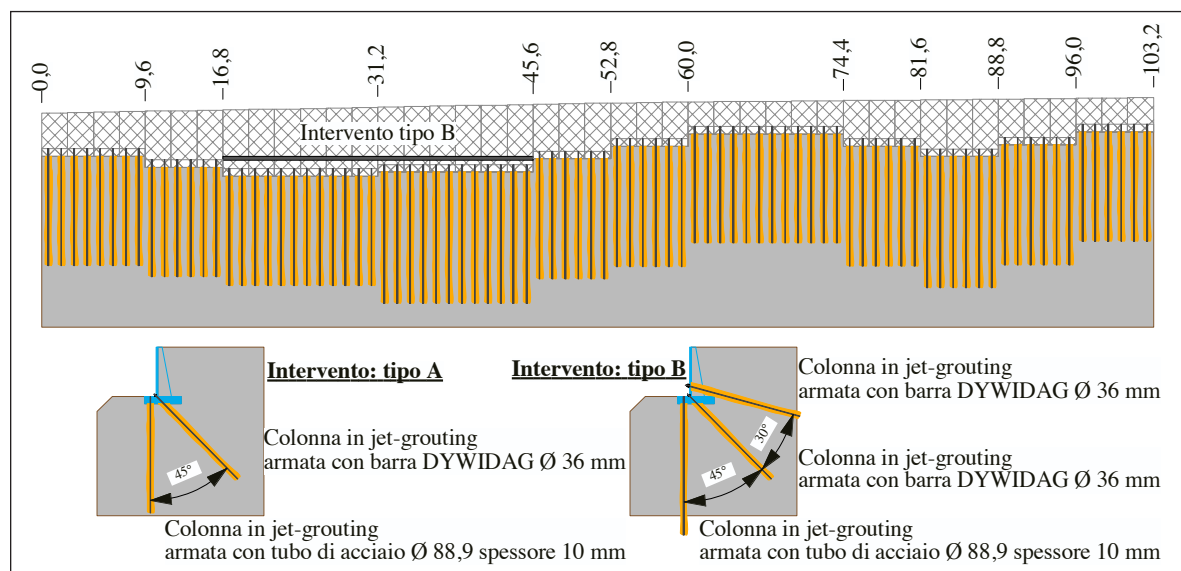
Fig. 4. Cross section of works.

The works were divided into three separate stages (Fig. 4):

- a anchorage of foundation beam;
- a consolidation of foundation beam soil;
- a consolidation of fissured panels.

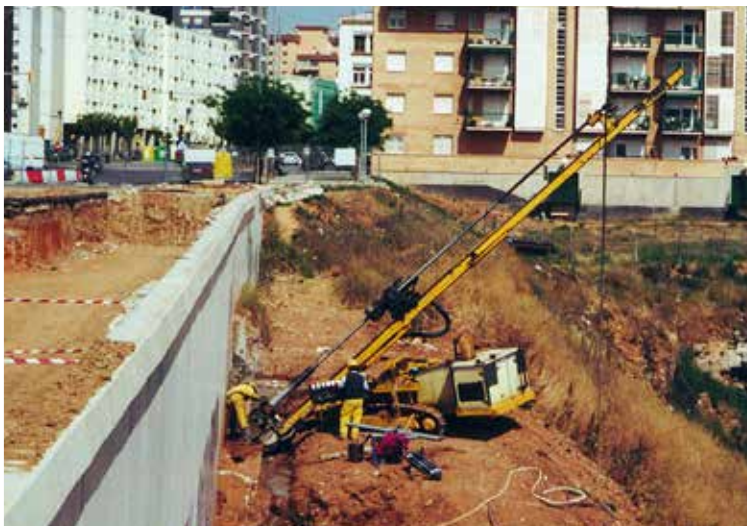
Fig. 6. PRP 105 drill rig during the anchoring of foundation beam.

The treatment was performed with a row of Jet Grouting columns tilted at a  $45^\circ$  angle, variable pitch, reinforced with a Dywidag passive tie rod (diameter 36 mm), 11 m long, diameter 700 mm (Fig. 6 - 7).

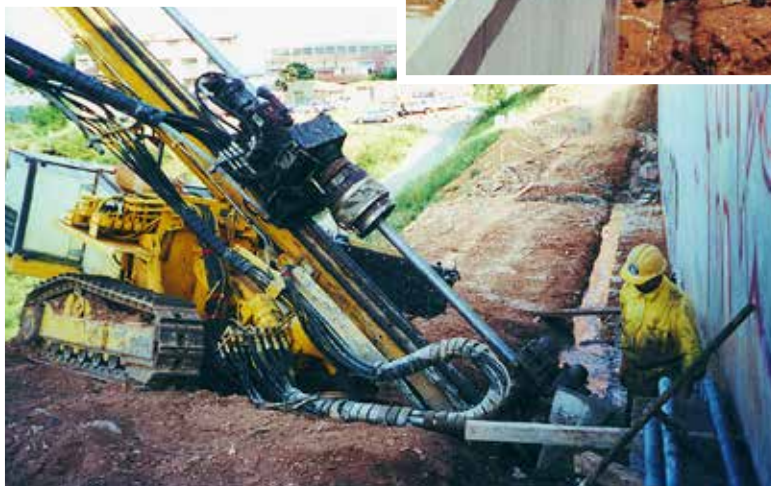
Fig. 7. Detail of intervention.

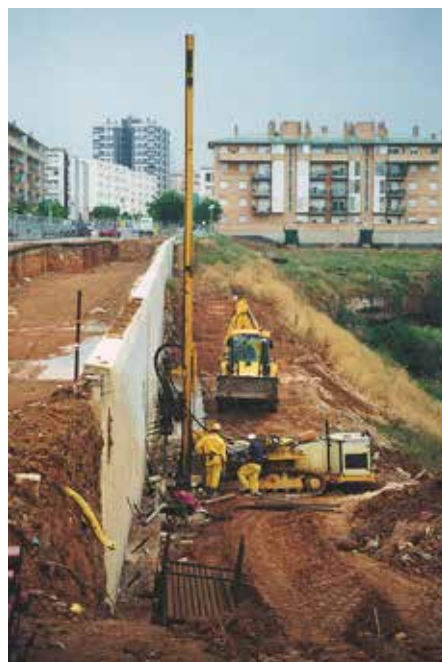
Fig. 8. PRP 105 durante il consolidamento delle fondazioni.

The treatment was done with a row of vertical Jet Grouting columns, spaced every 1.20 m, reinforced with steel tubing (diameter 88.9 mm, thickness 10 mm), lengths from 10 to 12 m, diameter 700 mm .(Fig. 8).

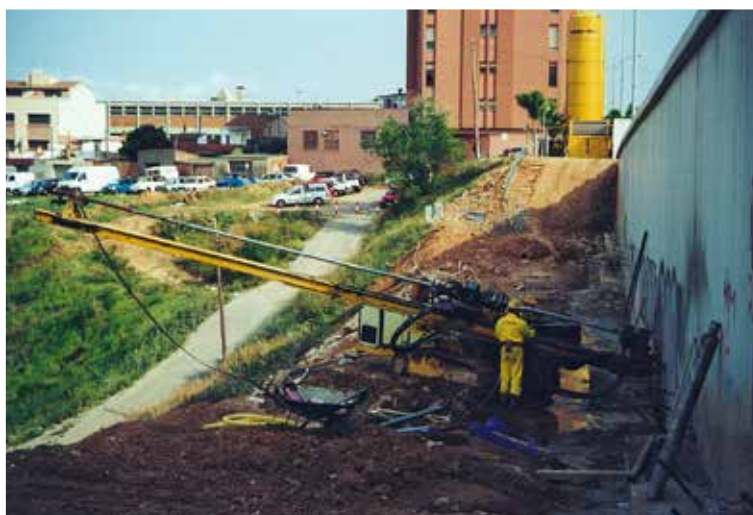
Fig. 10. PRP 105 drill rig during consolidation of the foundations

The works were completed by laying two load-sharing beams (HEB 140), along the section involved in cracking, one above and one below the row of tie rods (Fig. 9 and Fig. 10 ). The load transmitted by the plates positioned on the anchorages was distributed on the beams.

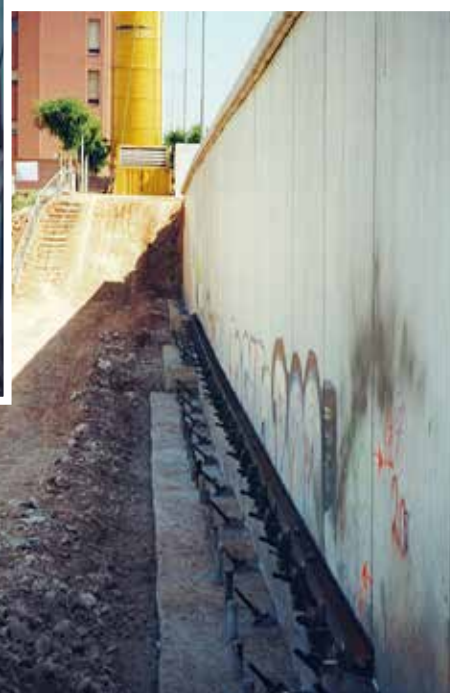
Fig. 9. Detail of load-sharing beams.

Treatment consisted of a row of Jet Grouting columns tilted at a 15° angle, with a spacing of 1.20 m, reinforced with a Dywidag passive tie rod (diameter 36 mm), length 11 m, diameter 700 mm (Fig. 9).

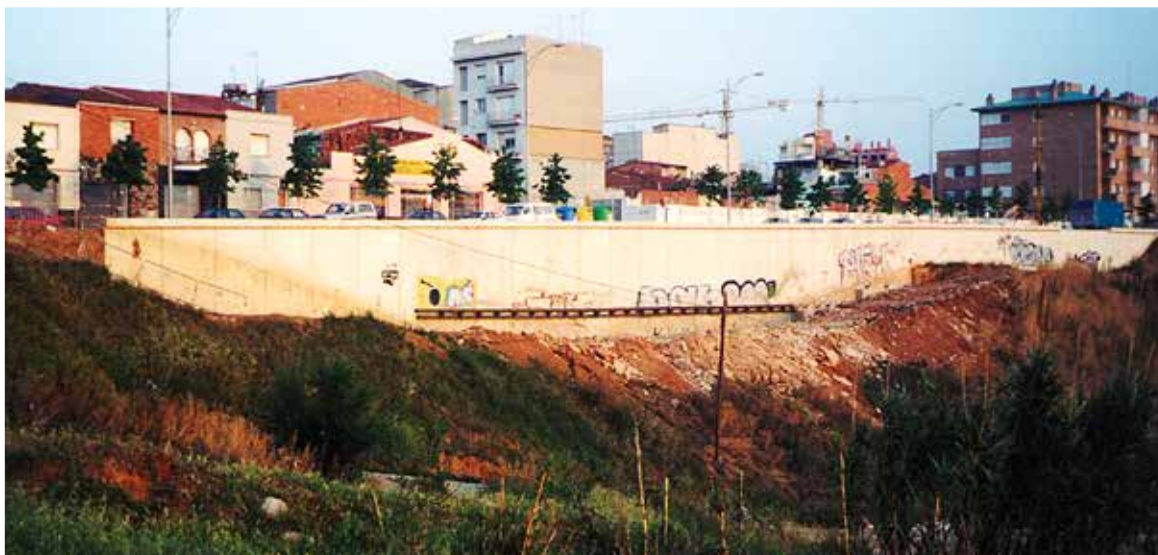
Fig. 11. View of the consolidated wall.
