WATERPROOFING

CLIFTON (NEW YORK - U.S.A.)

Jet Grouting remedial works to eliminate or mitigate the threats associated with the presence of the subsurface contaminants at the Former Clifton OU-1 Manufacture Gas Plant (MGP), located in the Borough of Staten Island, New York.

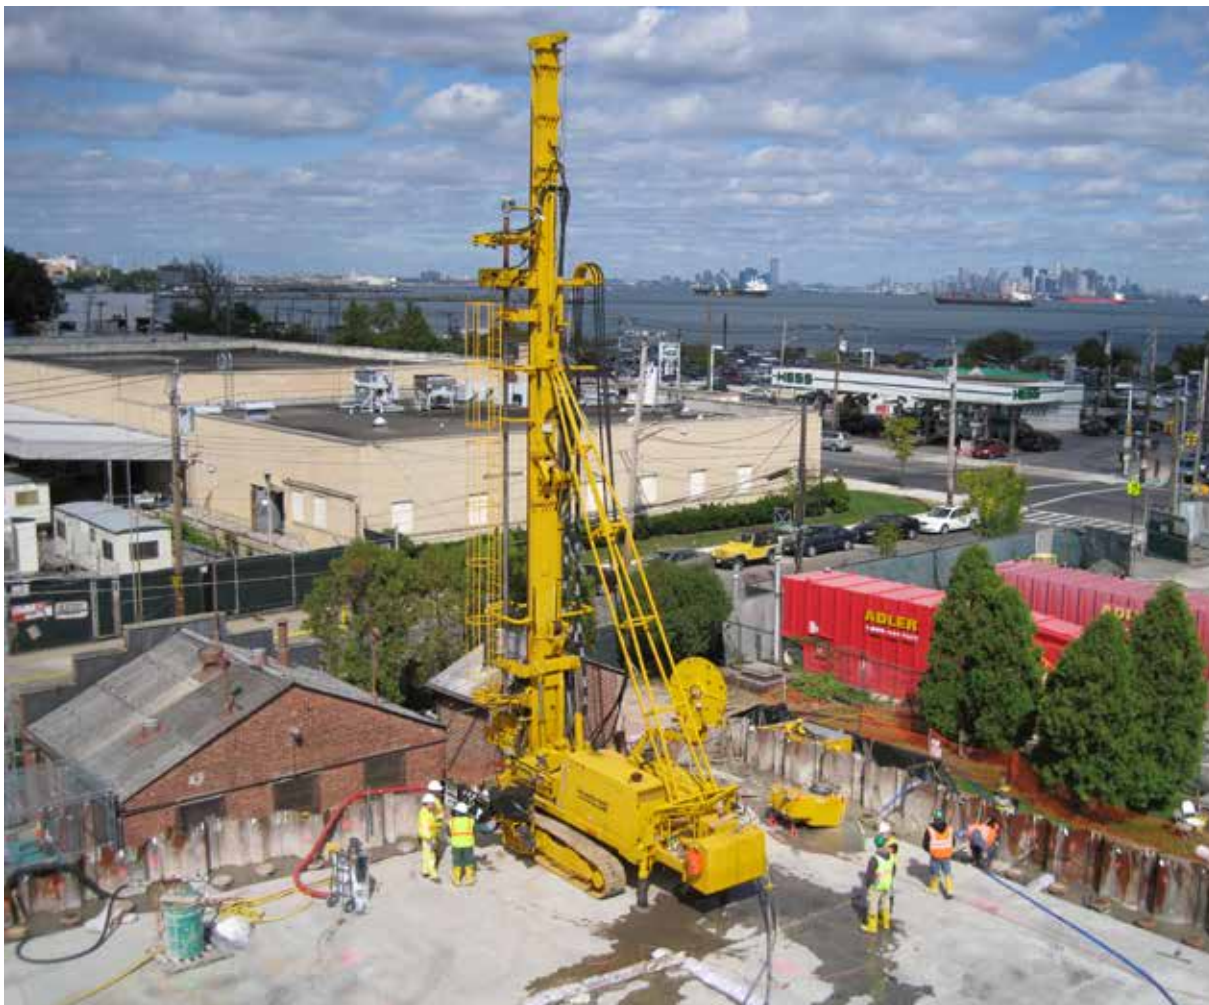
Fig. 1. Former Clifton OU-1 MGP site.

From 1856 to 1957 the Clifton MGP facilities produced combustible gas by heating coal and petroleum products. The OU-1 site is the location of a former relief holder used to store gas. The structure was demolished in 1959, leaving in place the subsurface portion of the 26 m diameter circular brick foundation. Over the years, by-products, such as coal tar generated from the MGP operations have leaked or been released from the former relief holder resulting in the contamination of soil and groundwater. In 2004, the New York State Department of Environmental Conservation (NYSDEC) issued a record of decision recommending a remedial concept for the OU-1 Site.

A key element of the remedial project was the installation of a vertical barrier containment wall consisting of a combination of shallow steel sheet piling with sealed interlocks and deep jet grouted column wall to surround and encapsulate the foundation structure associated with the former relief holder structure as well as the impacted source material.

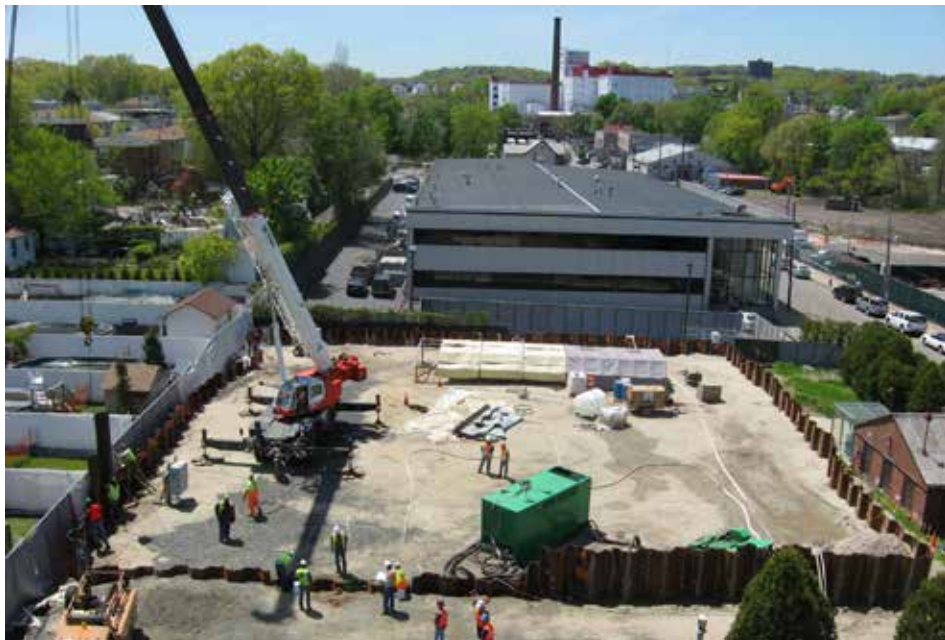
Fig. 2. Perimetral shallow steel sheetpiling .

Pacchiosi Drill began the construction of the jet grout vertical barrier wall in 2008, after the installation of the shallow steel sheetpiling wall with sealed interlocks to an average depth of 9.5 m had been completed by Others.

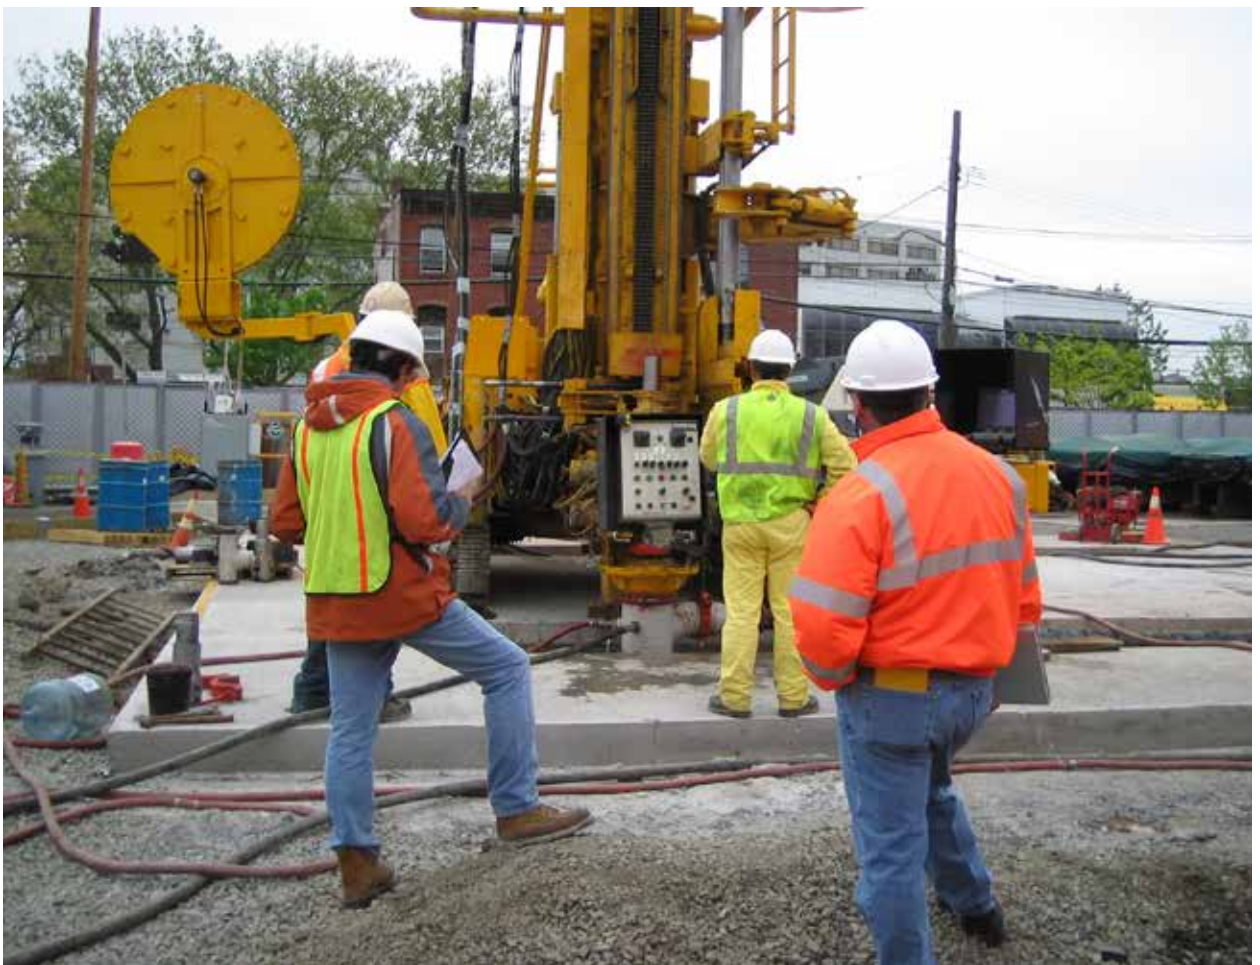
Two methods of drilling were tested during the trial field: rotary drilling using tungsten button tri-cone roller bit and percussion drilling using water-activated down-the-hole hammer. The later method proved the most efficient in dealing with the numerous cob-

Fig. 4. Trial field operations.

bles and boulders present in the glacial deposits and was used for the majority of the jet grout columns of the trial field. An average drilling deviation of 0.96% at a depth of 38 m bgs was obtained for the six columns, with the largest deviation measured at 1.51%.

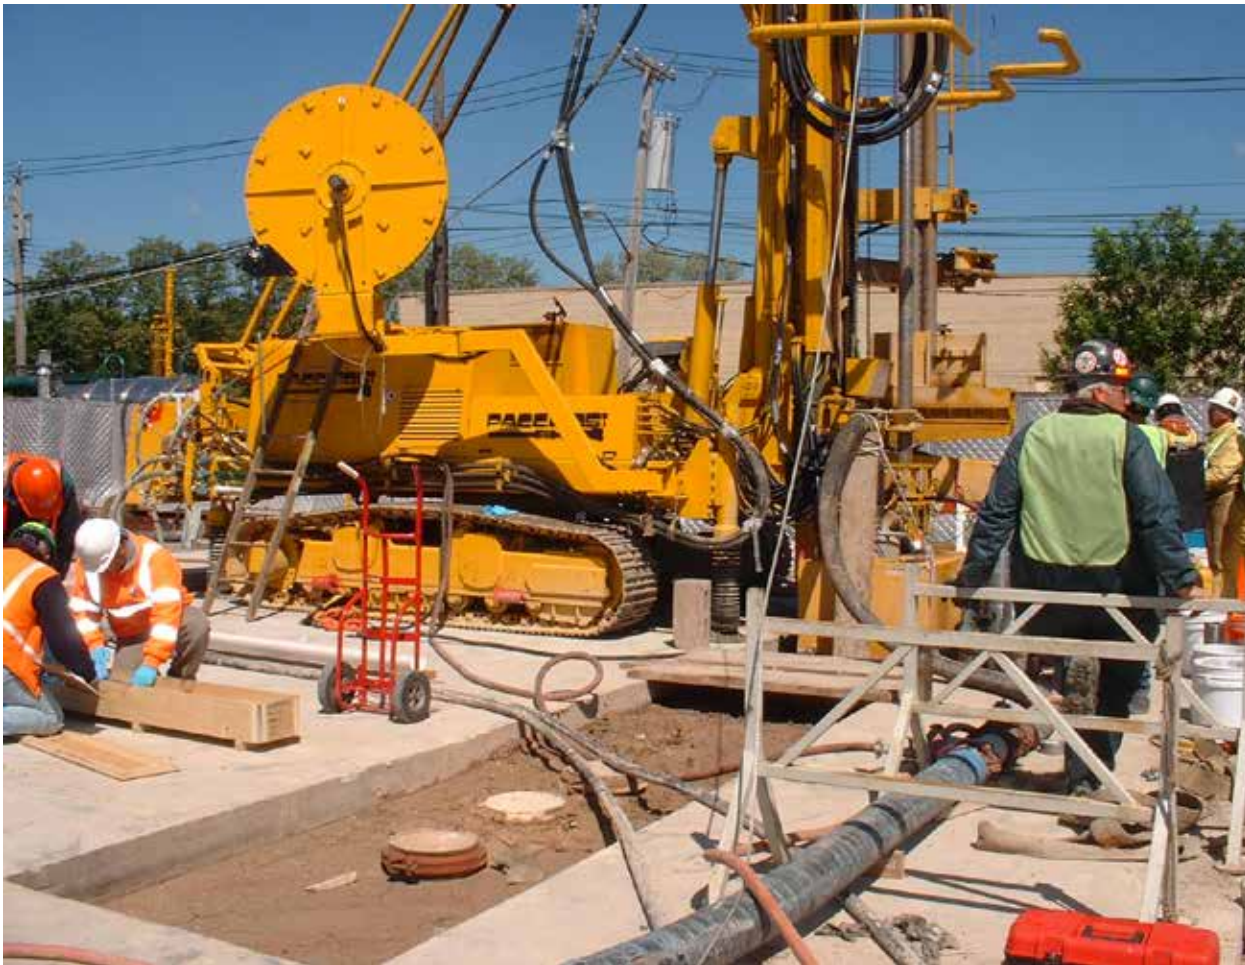
The jet grouting treatment was cored at six different locations, including all the overlaps of columns at a point corresponding to the mid-distance between the two adjacent columns. Deviation of all core holes were surveyed full-depth of drilling and the results used to generate as-built drawings showing in plan view, in 3 m depth increment, the actual location of the core hole in relation with the actual center location of the columns. This information allowed the Owner's Engineer to calculate that a diameter of 1.8 m had been achieved through all stratigraphic layers.

Fig. 5. Trial field operations.

Pump-down water tests were performed in each core hole to evaluate the in situ permeability of the jet grouted columns, and camera inspection was performed inside each core hole after having pumped the water out. The results of the water tests indicated that the permeability value of the jet grouted soil was of the order of 1×10^{-6} cm/s which was well in compliance with the criteria of maximum in situ permeability value of 1×10^{-5} cm/s established for the project.

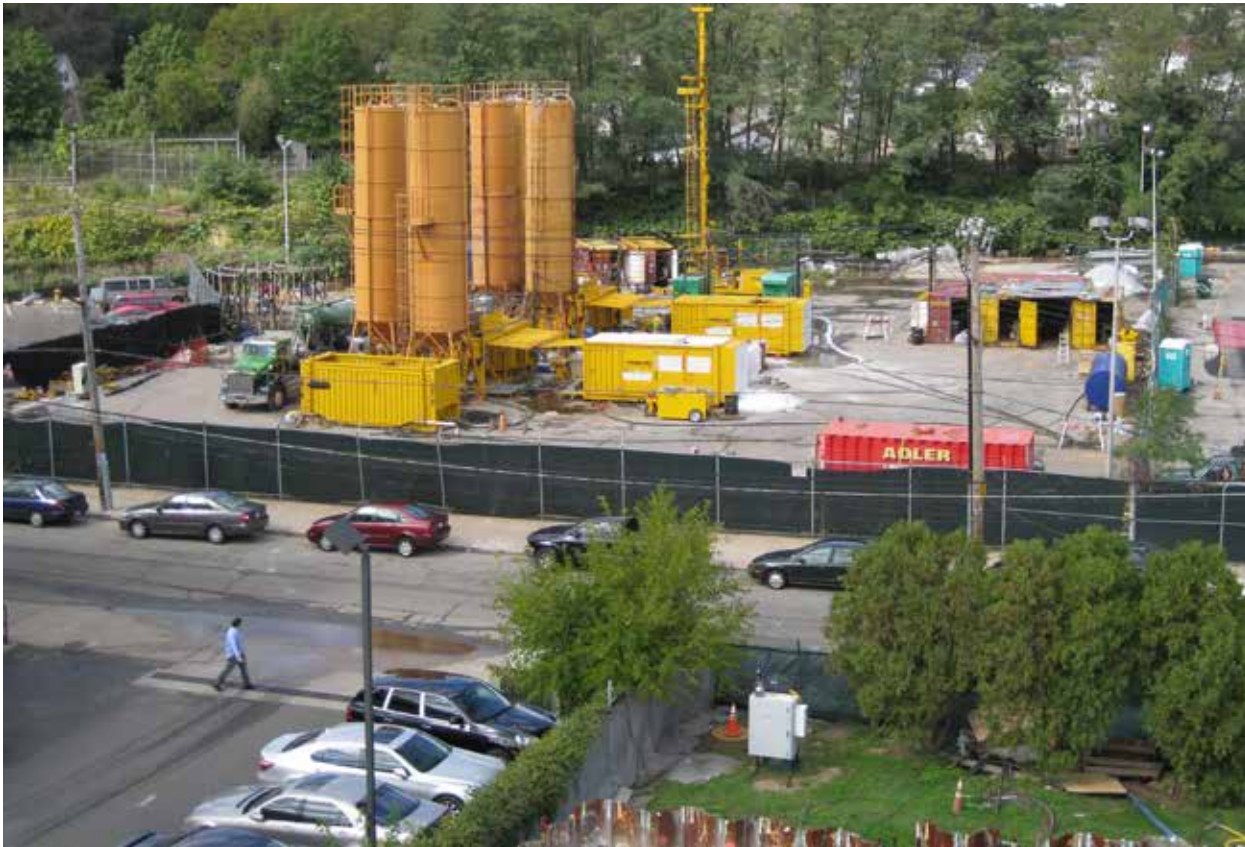
Fig. 10. PACCHIOSI Jet Grouting plant installations.

Two drill rigs PACCHIOSI P1500 ECS model, equipped with an automatic rod charger, were used for the performance of the jet grouting work. One rig was used for the full depth pre-drilling of the jet grout boreholes while the other rig was assigned to the jet grouting operation.

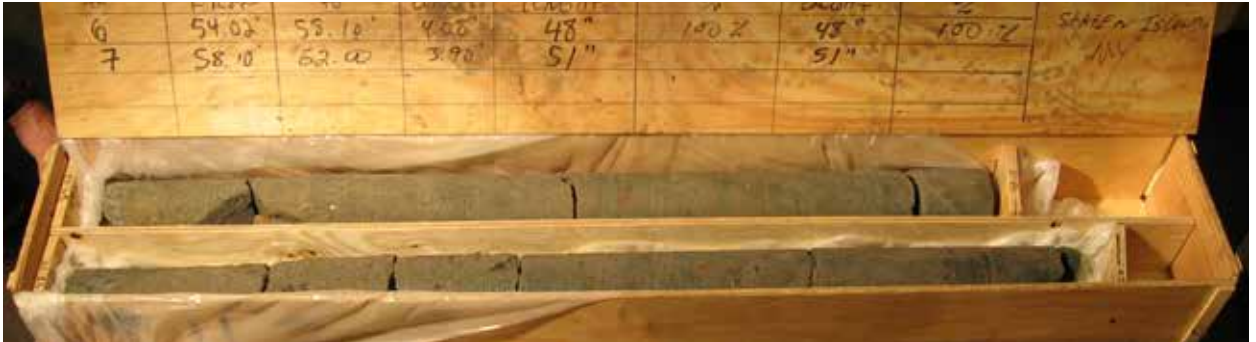
Excellent core recovery, close to 100%, with very good quality and continuity of jet grouting treatment, was obtained for all core borings and through all stratigraphic layers, including in the jet grouted soil zones with a large content of boulders and cobbles.

Fig. 11. Coring of fine alluvial deposit.

To confirm the quality of the in situ jet grouting treatment and the compliance with the contract specifications, core drilling was performed at 15 locations along the jet grout wall, using a double-tube core barrel assembly providing core samples 108 mm in diameter. The majority of the core hole locations were selected by the Owner's Engineer to correspond to minimal overlap of columns as shown by the as-built column drawings. Full-depth alignment of all core borings was surveyed using the bi-axial inclinometer.

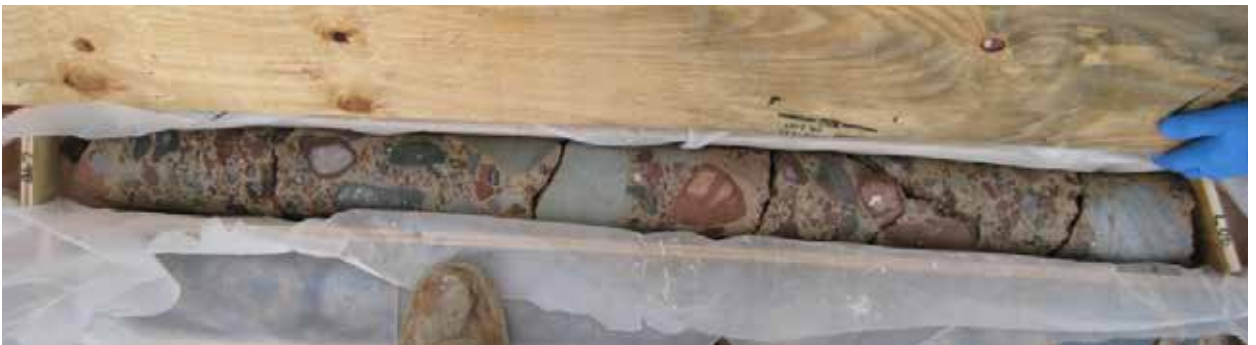
Boulders up to 1.5 m in length were sampled during the coring program.

Fig. 12. Coring of grouted glacial deposit, with boulders and cobbles.

Water pump-down tests were performed in all core holes to evaluate the permeability of the in situ jet grouted material. All water tests showed permeability values well below the maximum permeability of 1×10^{-5} cm/s established for the project with all,

but one, permeability values lower than 5×10^{-6} cm/s and typically in the 1×10^{-6} cm/s range. Considering the high stress induced to the in-situ jet grout treatment by the core drilling process itself, it was generally believed that the true permeability values of the undisturbed in situ jet grouting treatment were lower than those actually measured by the field tests. Considering the relative young age (14 to 28 days) of the in situ grout at the time of the coring, it is also anticipated that the low-permeability characteristic of the in situ grout will continue to improve over time.
