AMERICAN RIVER COMMON FEATURES - SACRAMENTO RIVER EAST LEVEE, CONTRACT 2

Installation of a permanent seepage cutoff wall by jet grouting method in order to correct levee deficiencies identified throughout the flood protection system along the east bank of the Sacramento River (Sacramento - California).

March 2021 – February 2022

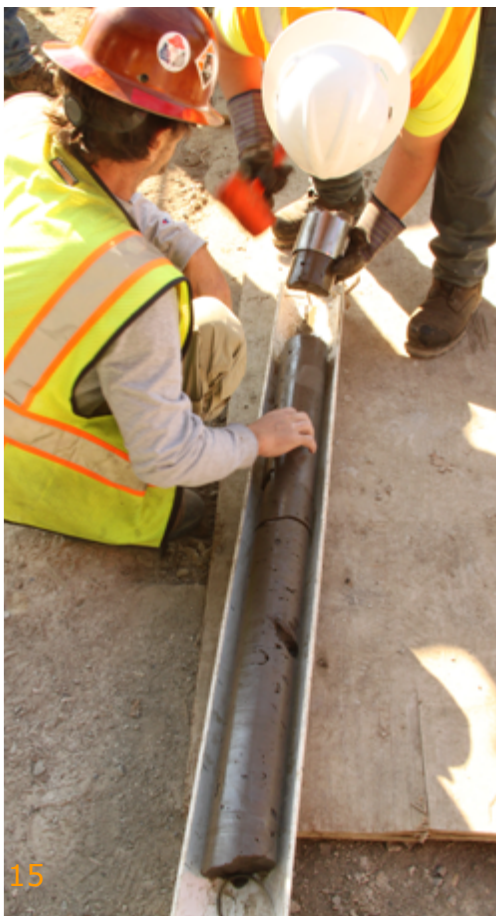
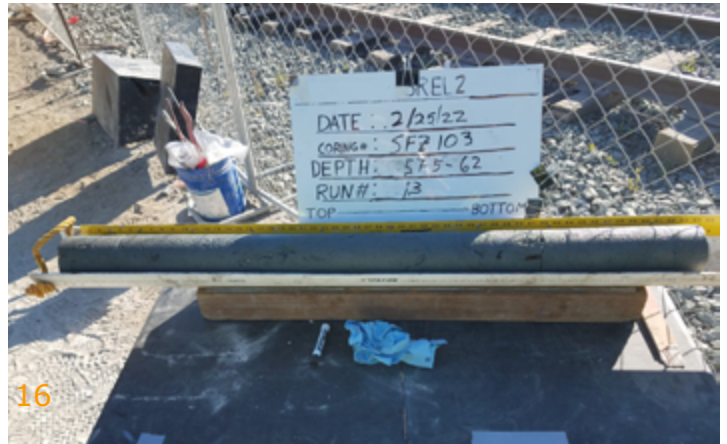
Fig. 15 | 16 | 17 - Checks carried out on the columns by means of core drilling.

The jet grout wall thickness and continuity has been verified using core drilling at numerous locations and through the full depth of the jet grout wall. Specified maximum permeability of 1×10^{-5} cm/s was verified using in-situ water testing of core holes and laboratory tests on cored samples.
