ROCKAWAY PARK (NEW YORK - U.S.A.) -

Vertical jet grouting barrier for containment of polluted subsoil.

Making safe a former industrial area used for the manufacture of gas for civilian use; intervention aimed at eliminating the potential risks of migration of highly polluting substances from the subsoil to the adjacent "Jamaica Bay" nature reserve, located on the peninsula of Rockaway Beach in the Southern District of Queens, New York.

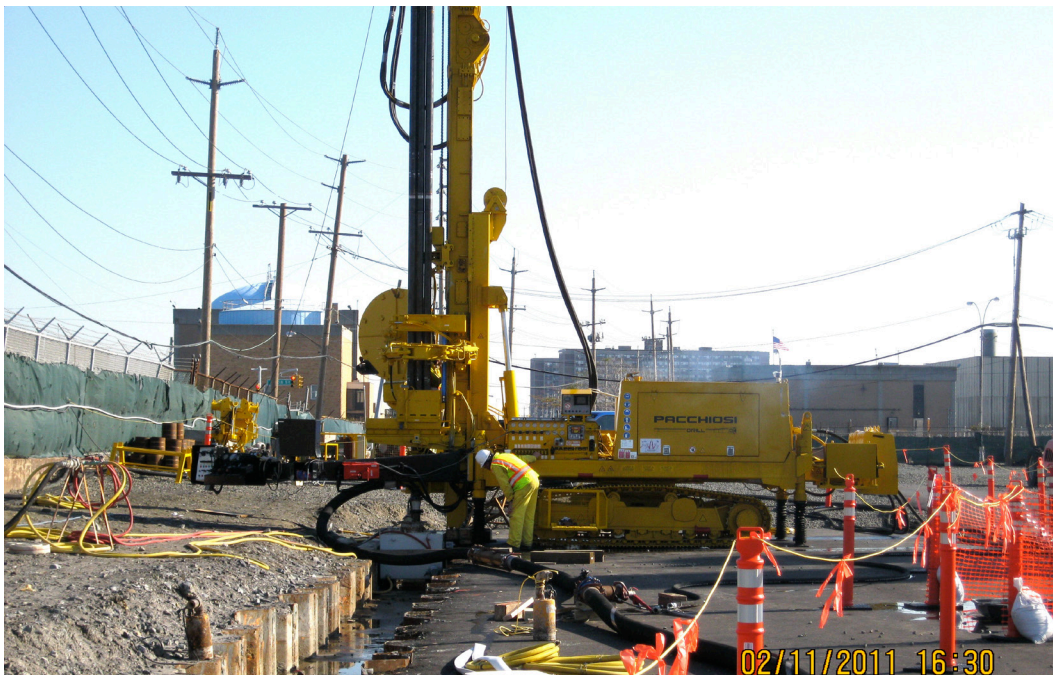
Fig. 1. P1500ECS drill rig positioning

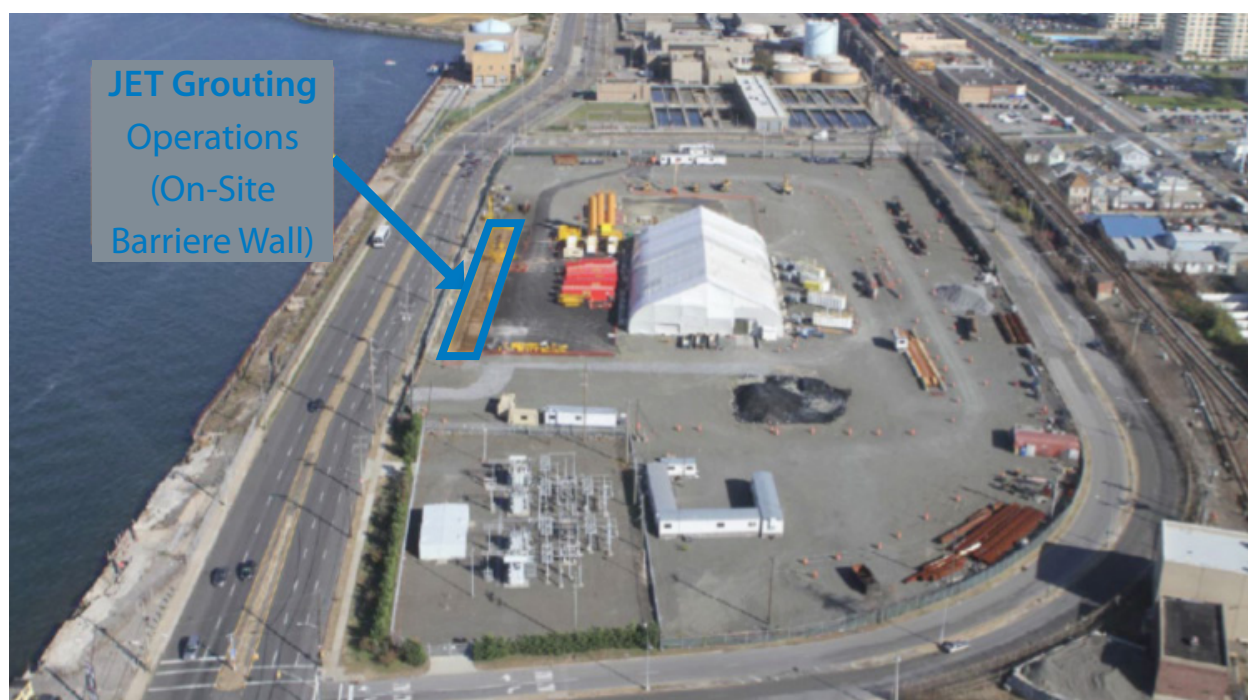
Fig. 3. View of Rockaway Park MGP area during works

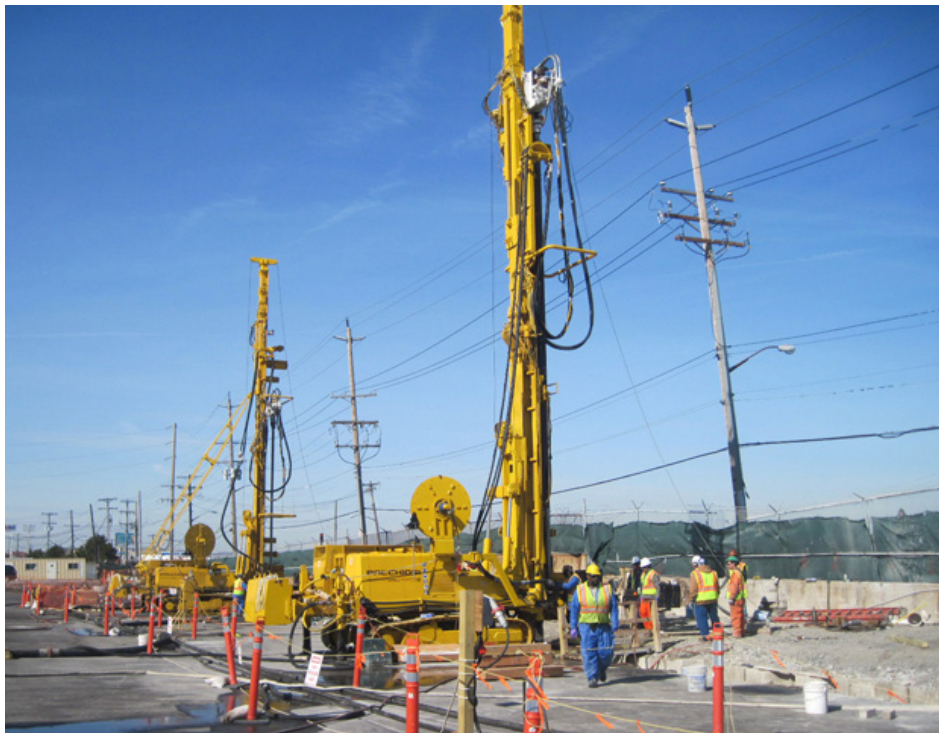
Fig. 5. PACCHIOSI P1500ECS drill rigs operating with automatic rod loader

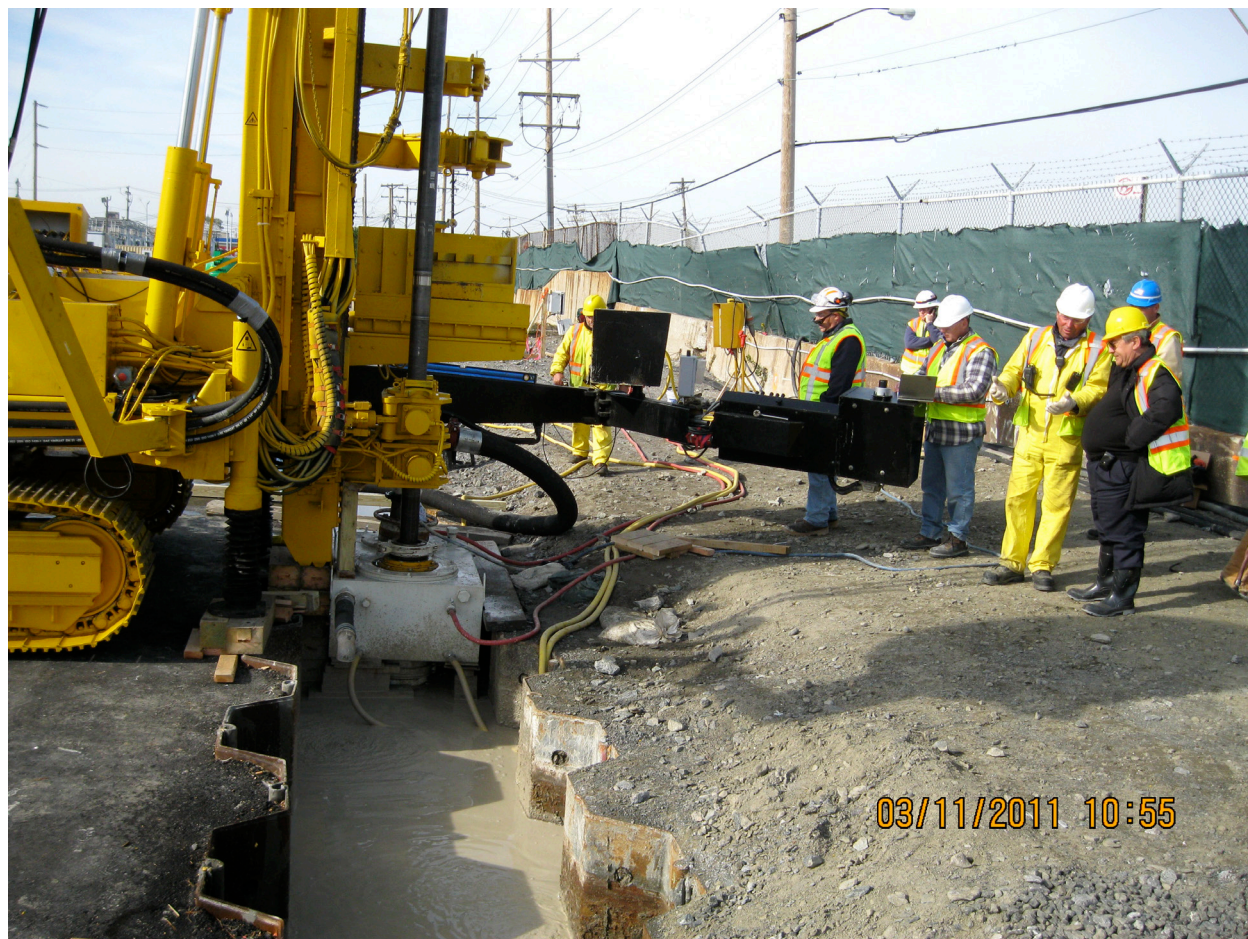
Fig. 6. Special watertight tank used for Jet Grouting spoils' collection

On the basis of previous experience in a highly polluted site similar to Rockaway Park MGP (see brochure CLIFTON N.Y.C.), the same equipment and methods were used in relation mainly to the recovery of injection waste water; these were managed through the use of a preventer directly placed on the concrete slab and a watertight tank equipped with a pump to remove the waste water and transfer it to the respective treatment areas.

The waste water collection system, designed and built by PACCHIOSI DRILL allowed the systematic removal of waste water from the work site without the water, which contained highly toxic substances, coming into contact with the personnel working on site.

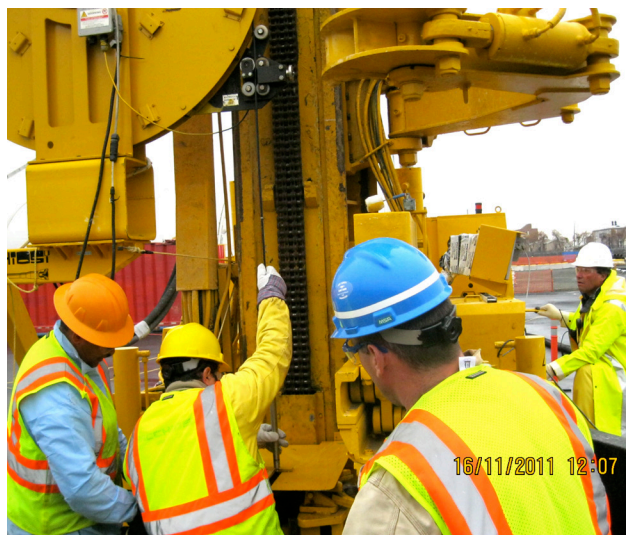
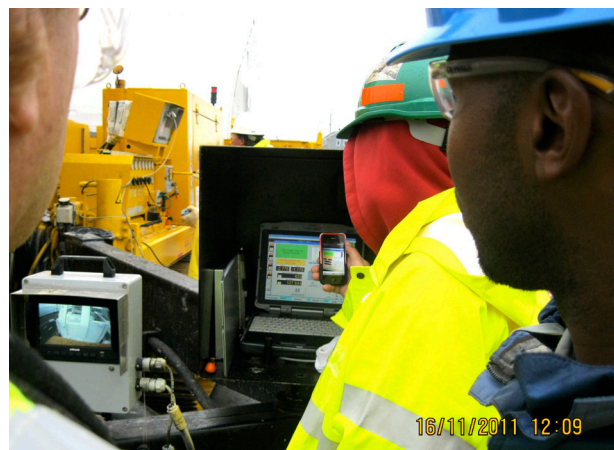
Fig. 7 e 8. Measuring of the deviation of drilled hole before injection

- the deviation from the vertical was checked on each individual bore hole before injection; the deviation was controlled using an inclinometer constructed by Pacchiosi Drill which has the special feature of introducing the inclinometer (equipped with a sensor and a biaxial gyroscope) directly into the drill and injection rods leading to extremely fast execution times compared to traditional measuring devices; the measurement data are processed in real time with immediate display of as-built graphics showing the position of the column along with the relative thickness of the wall under construction.

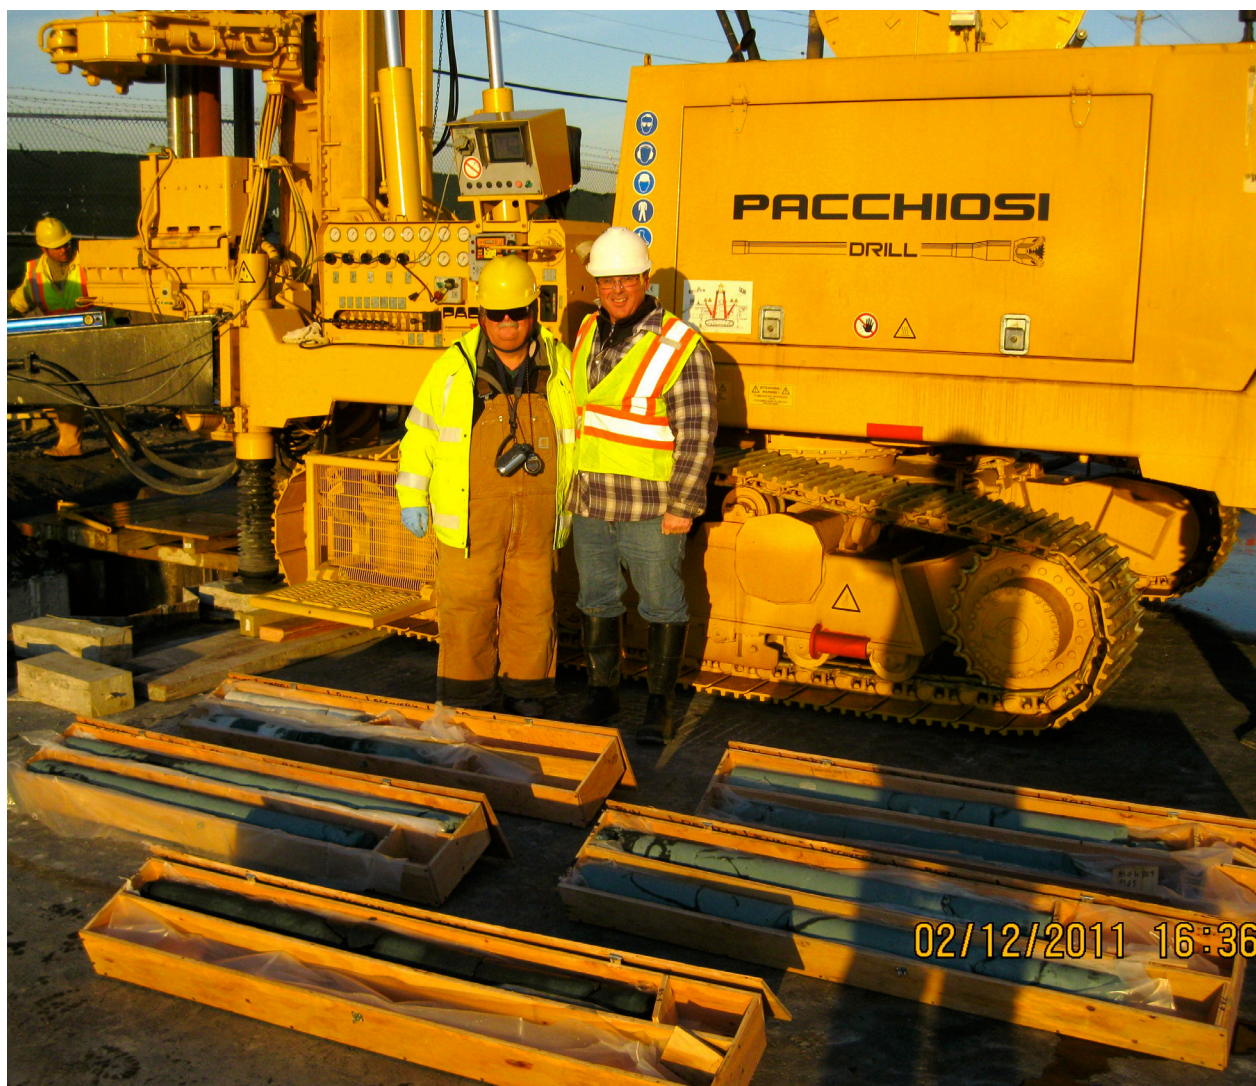
Fig. 9. Photographs of cored samples

- After execution of the columns core sampling is performed to verify their quality and durability; a further check is carried out visually with the aid of a micro camera (located inside the bore hole) that directly checks the quality of the inner walls of the columns.

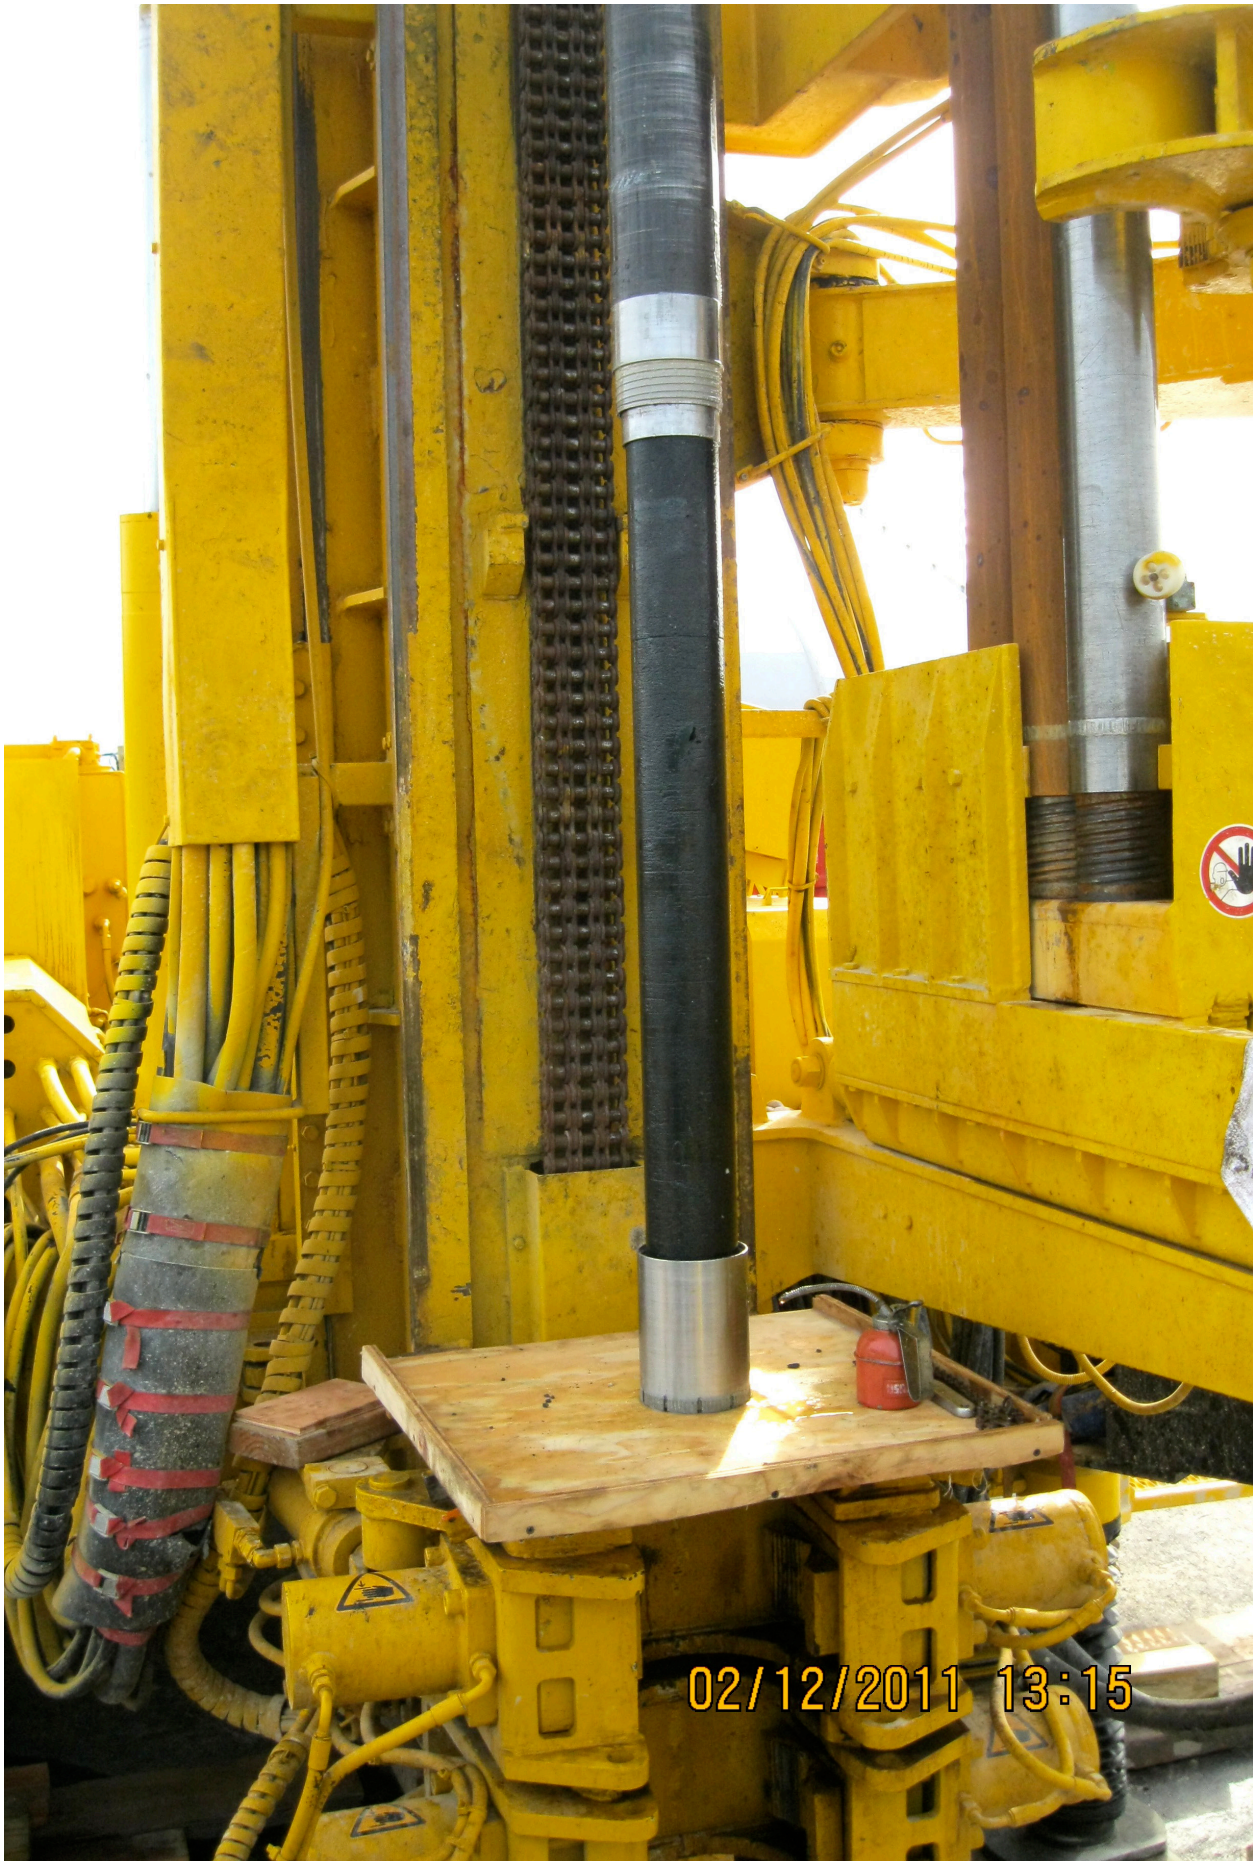
Fig. 10. Extraction of a perfect cored sample
