## SABADELL (BARCELONA - SPAIN)

Consolidation of the structural wall along the "Ronda de Santa Maria" road.

April – July 2001

Municipality of Sabadell

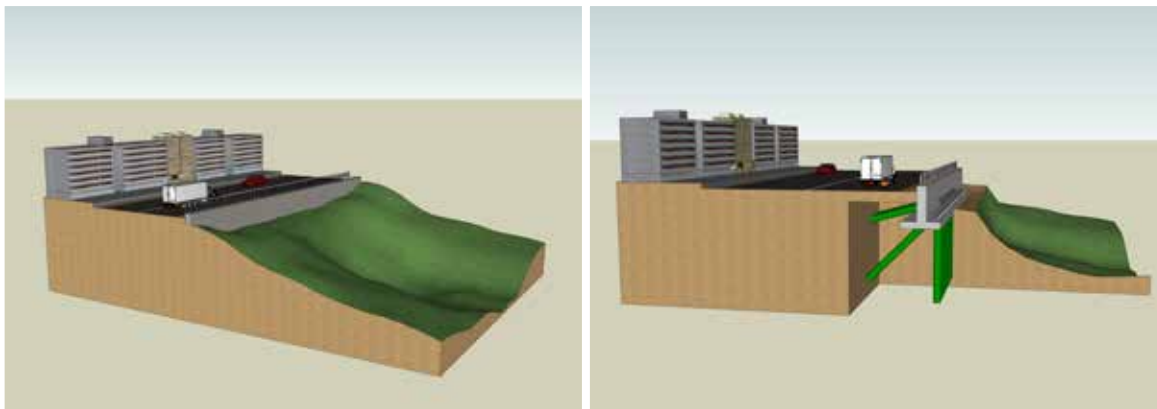
Fig. 5. Ricostruzione 3D dell'intervento.

The works were divided into three separate stages (Fig. 4):

- a anchorage of foundation beam;
- a consolidation of foundation beam soil;
- a consolidation of fissured panels.
