AIGUEBELLE - TUNNEL DES HURTIERES (FRANCIA)

Consolidation for protection of the excavation of the motorway tunnel in two sections "Tunnel des Hurtières" (in the lower Maurienne Valley), damaged by a geological incident.

July 1995 - March 1996

Scetauroute - S.F.T.R.F.

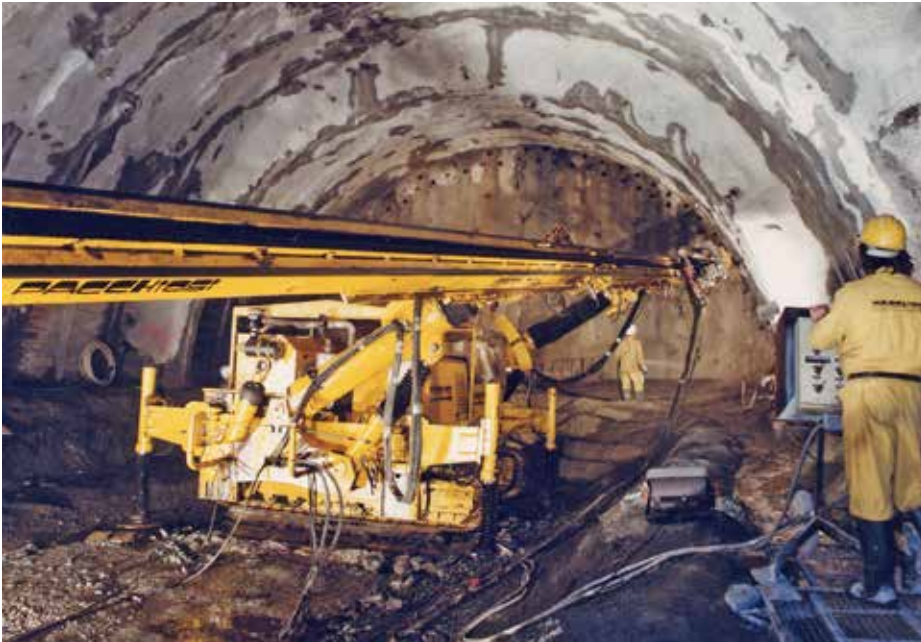
Fig. 4. P1500 TAF hydraulic drill rig employed for dome consolidation.

The works of consolidation were performed in two stages: consolidation of the half section and consolidation of the reverse arch (FigFig. 4).

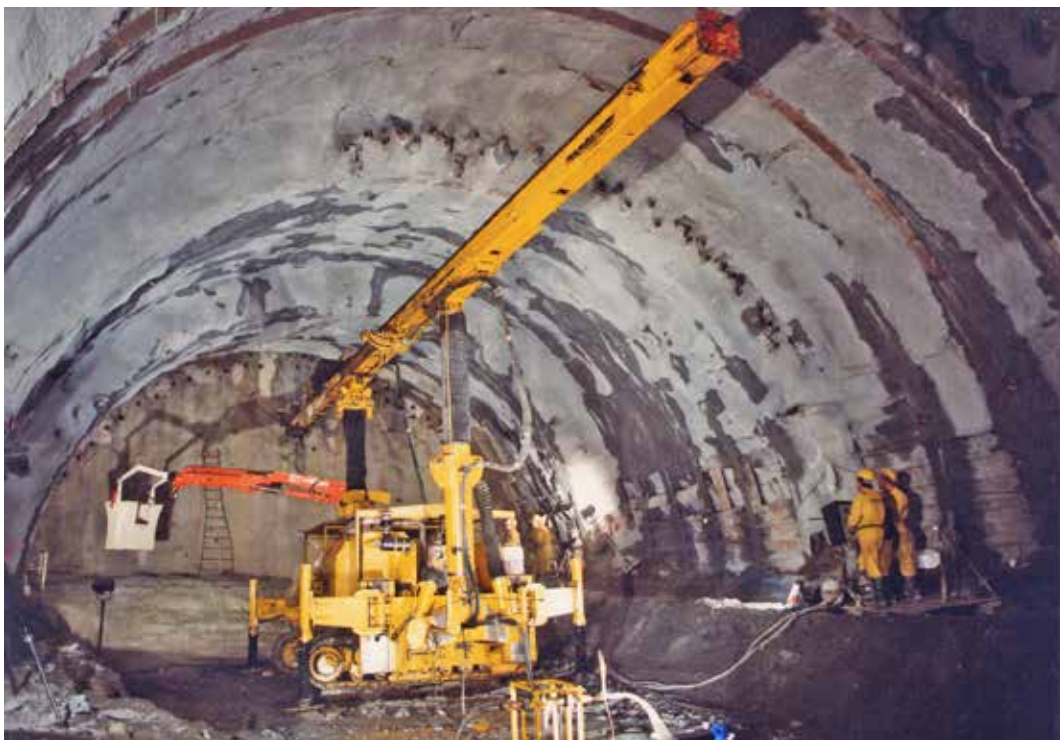
Fig. 7. P1500 TAF drilling machine during consolidation of the excavation front.

- b) consolidation of the excavation front by means of horizontal columns, reinforced with bolts in fiberglass, 18 m long, with a diameter of 80 cm (Fig. 7);
- c) consolidation under the cambers with construction of 7 sub-horizontal columns, not reinforced, 7 m long with a diameter of 60 cm.
- d) construction of drainages to the outside of the consolidation in the cap, 15-21 m long, equipped with microfissured pipe to discharge any accumulations of water.

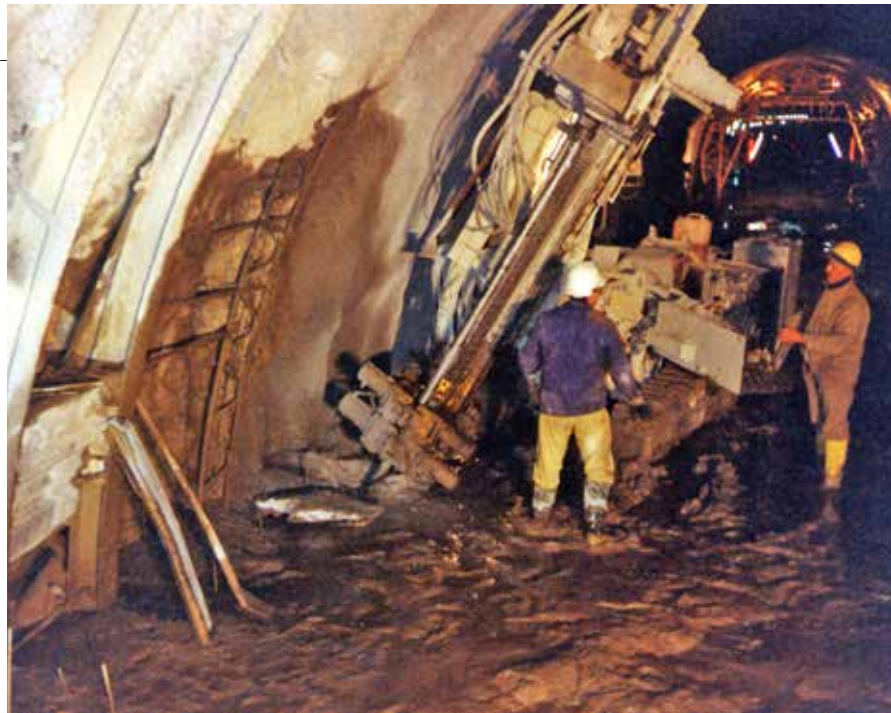
Fig. 9. PRP 105 drilling machine during consolidation of piers and micropiles.

- consolidation of the foundation soil of the reverse arch by means of sub-vertical columns, with a 1.5x2 m arrangement, not reinforced, 4 m long, diameter 60 cm;
- consolidation of piers by means of three sets of jet columns with variable tilt, not reinforced, 6 m long, diameter 60 cm (Fig. 8);
- installation of reinforcing micropiles at the feet of the cambers with jet columns tilted at a 45° angle, spacing of 50 cm, reinforced with steel pipe, 10 m long, diameter 60 cm (Fig. 9).

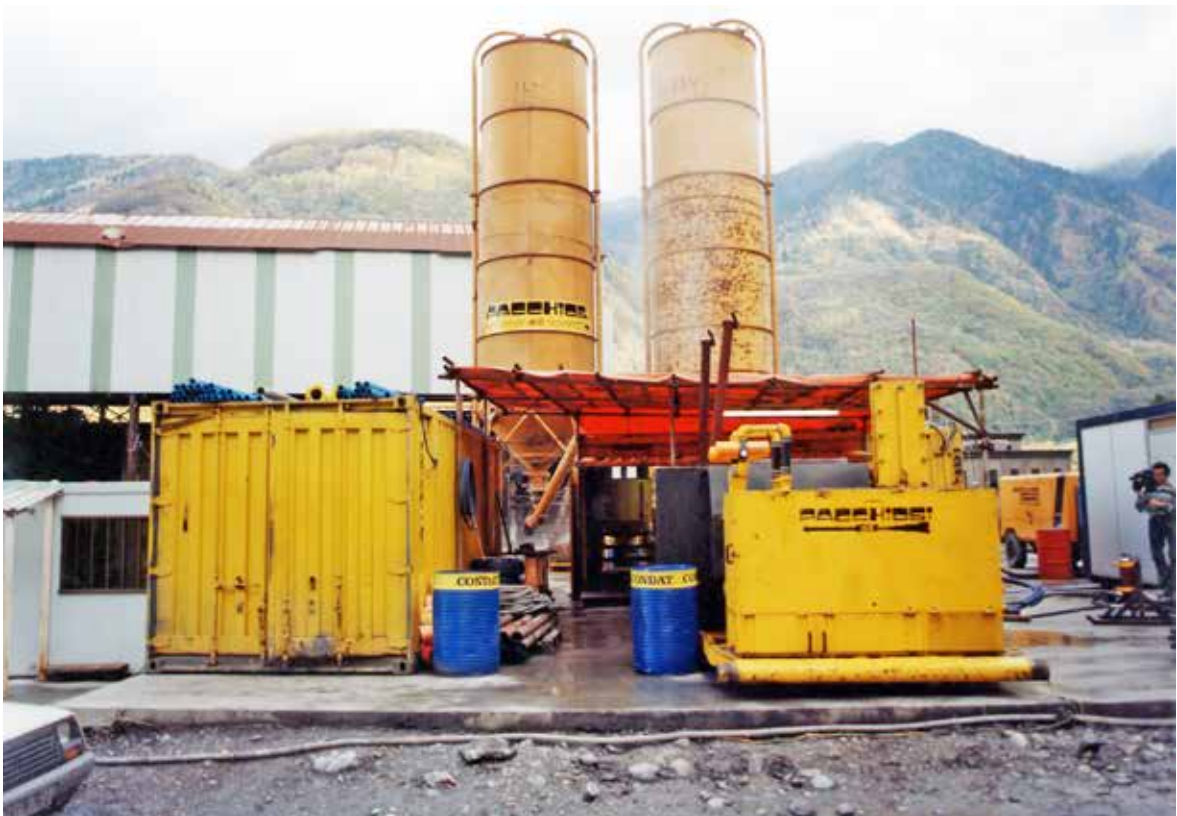
Fig. 10. Mixing and injection installations.
