FONTESCODELLA TUNNEL (MACERATA - ITALY)

Construction of the new Fontescodella tunnel that crosses the town from north to south, with works of completion and accessories, including technological and safety systems.

January 2004 – September 2008

Comune di Macerata

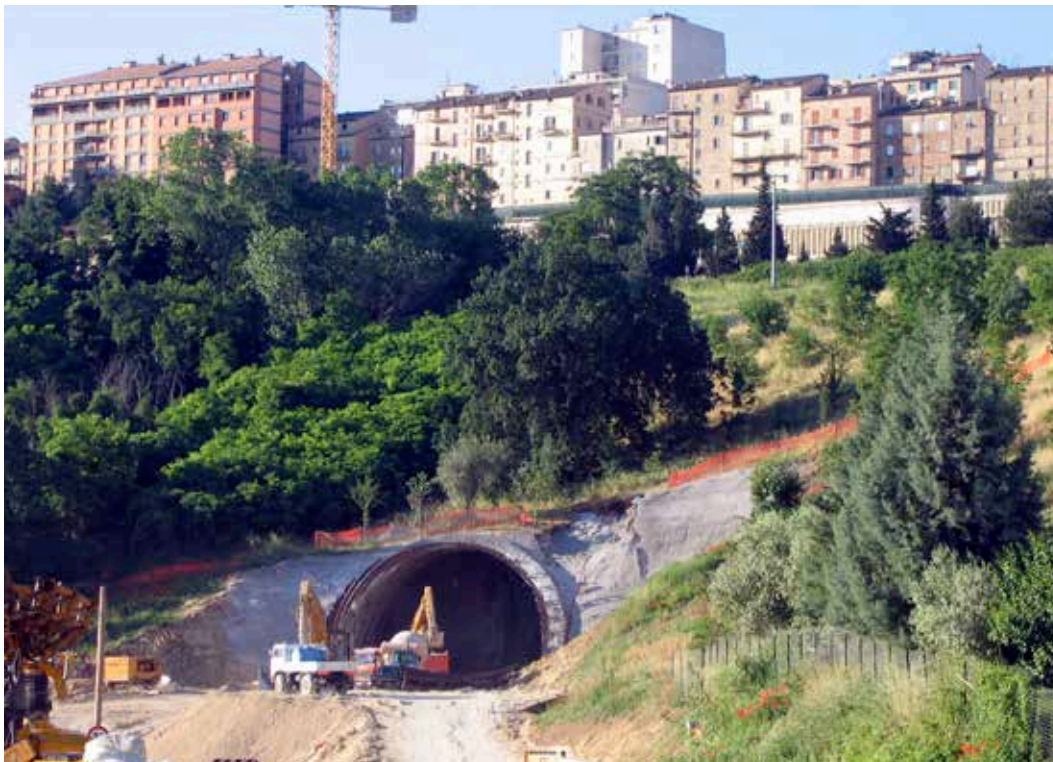
Fig. 1. General view of the northern entrance to the Fontescodella tunnel during the works.

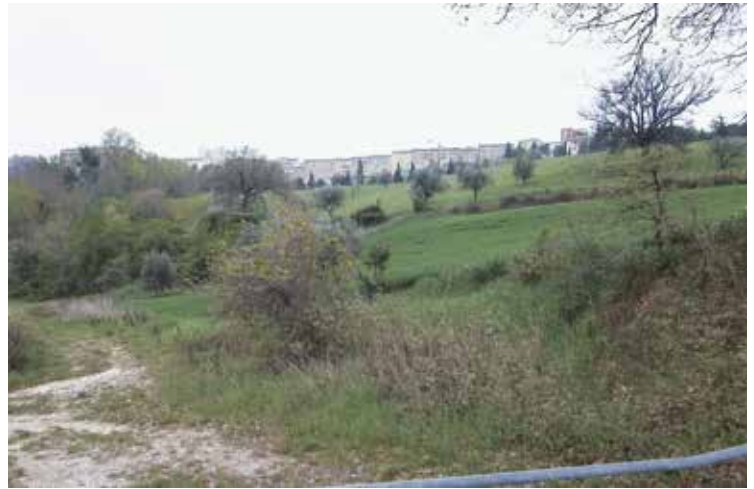
Fig. 2. Morphology of the area in the zone of the northern entrance.

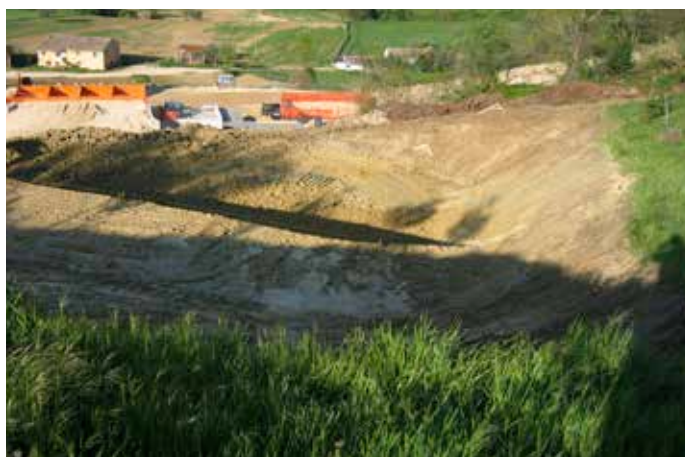
Fig. 7. View of the northern entrance prior to works of consolidation.

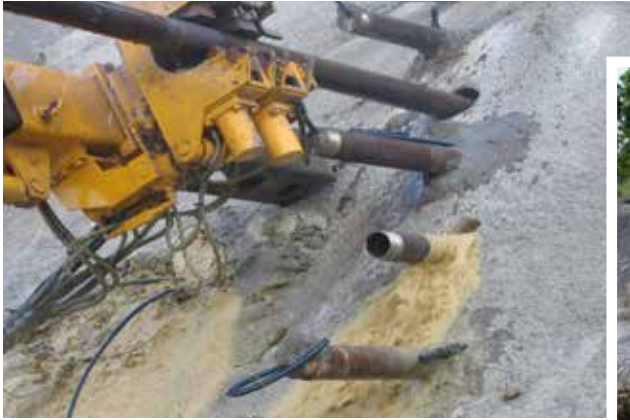
Fig. 8-9. Detail of construction and view of subhorizontal steel insertions preliminary to first attachment on the front.

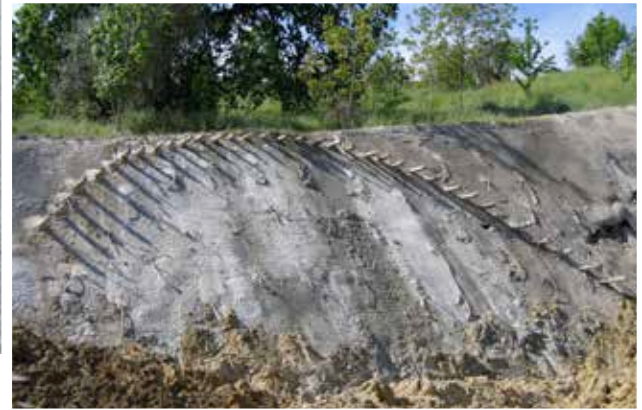
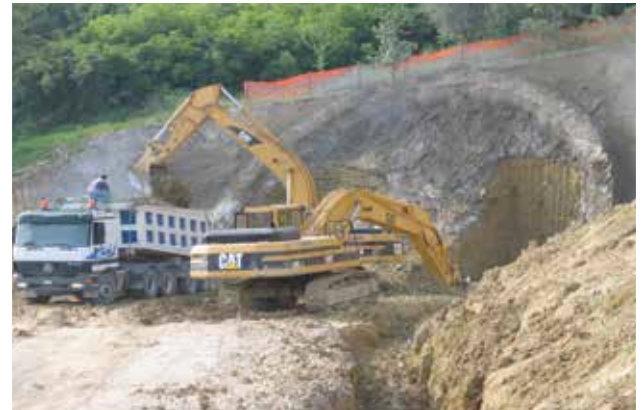
Fig. 10. Approach of excavation face at North entrance.

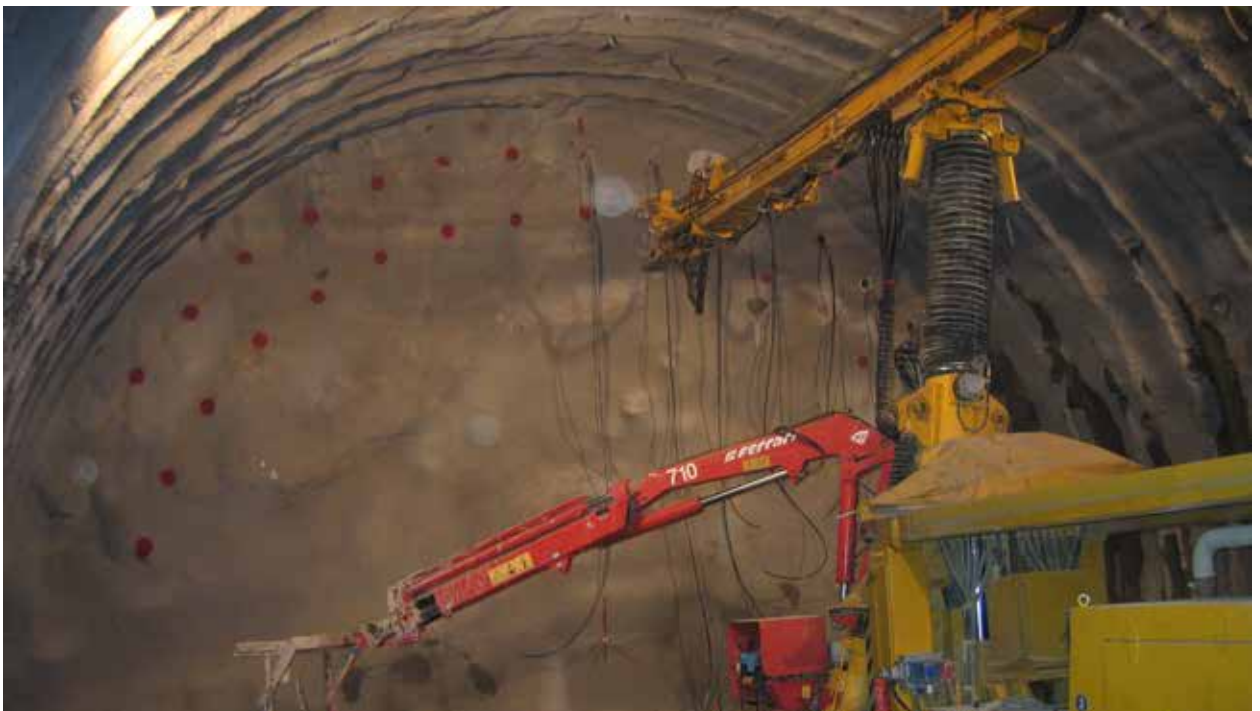
Fig. 11. PACCHIOSI P1500TAF drill rig executing the nailing of excavation face

After pouring the low walls and reverse arch, the final covering in concrete was poured at the site using special metal formworks (CIFA) for blocks 12 m long; with the exception of the openings and other particular position, it is not reinforced. For special works of consolidation, equipment designed and built by PACCHIOSI was used (in particular, the TAF hydraulic probe).

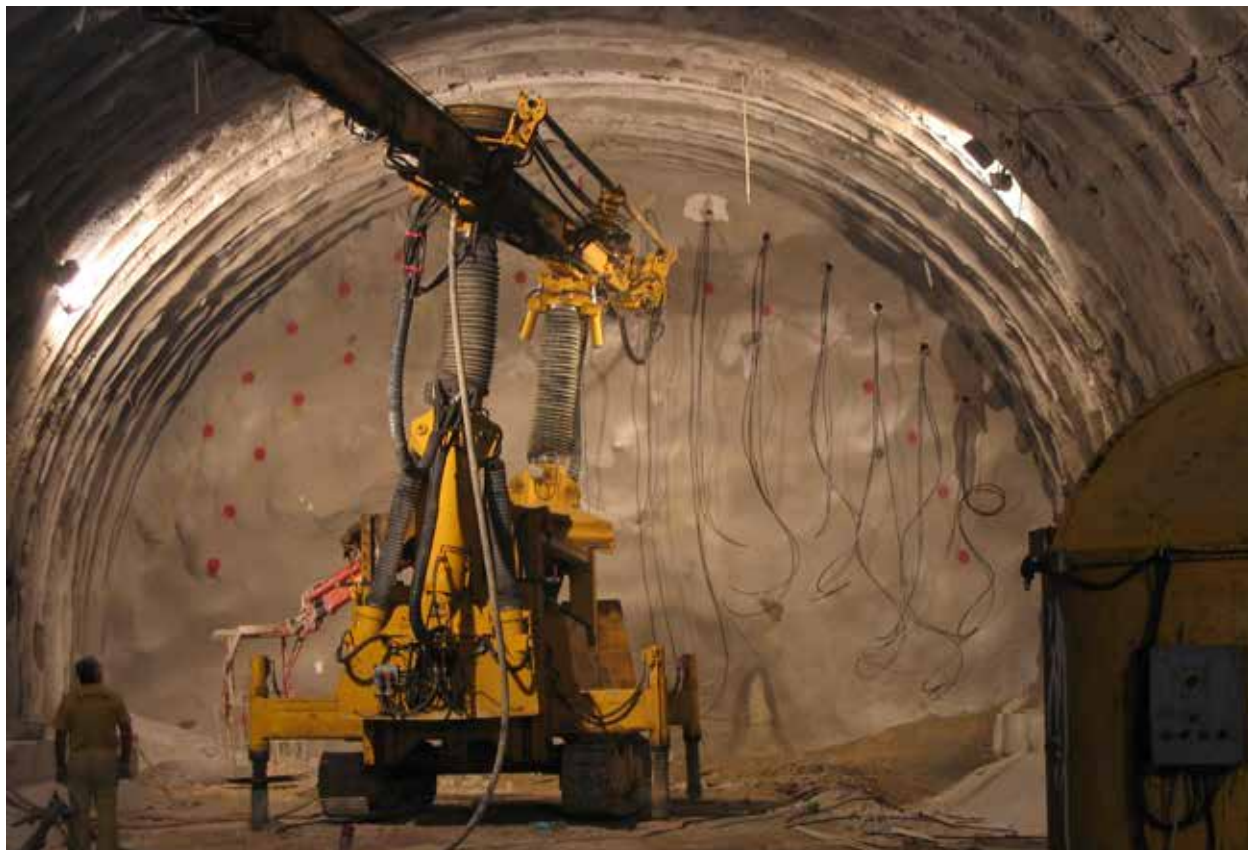
Fig. 12. Nailing of the front with PACCHIOSI P1500TAF.

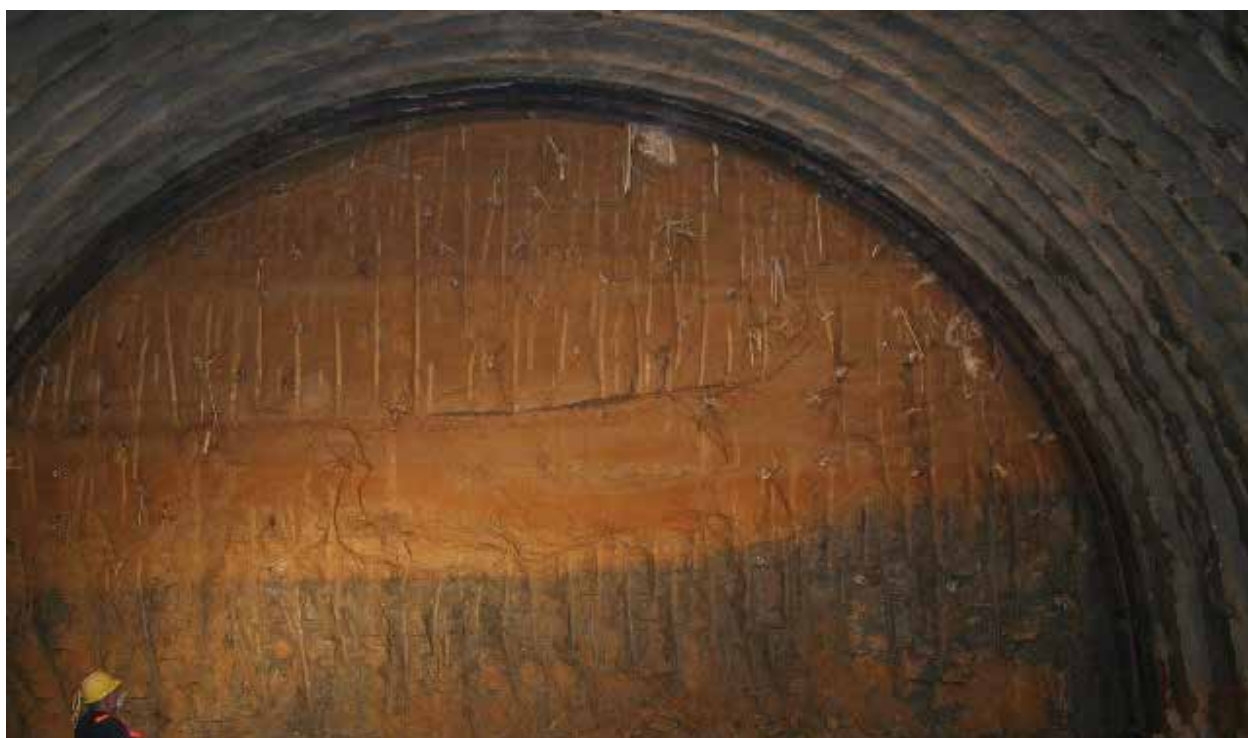
Fig. 13. Front of the excavation; the soil stratigraphy is visible.

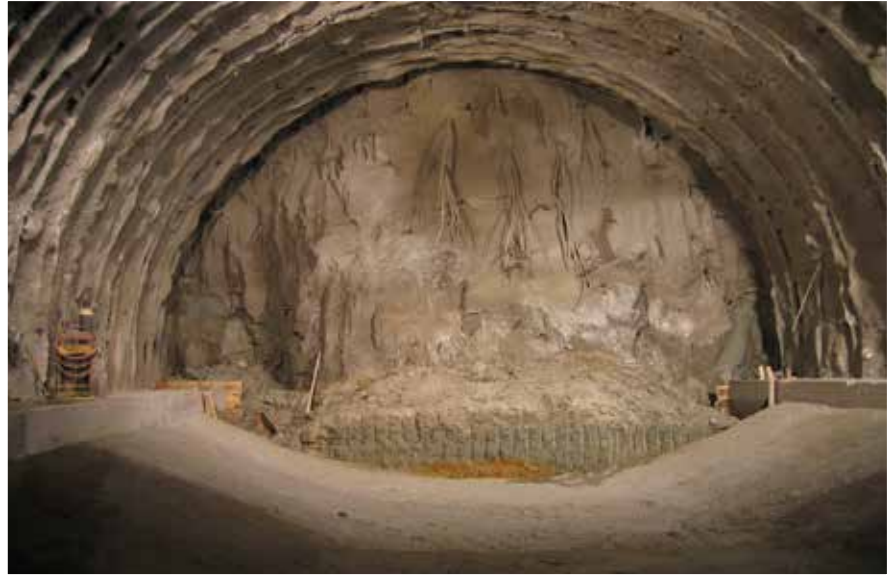
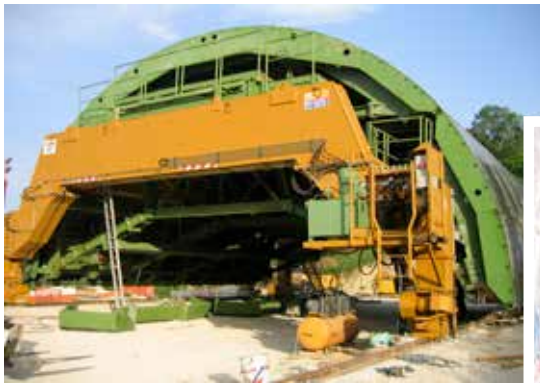
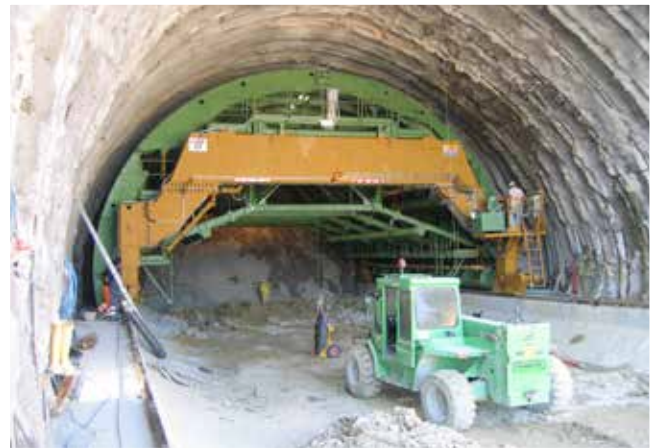
Fig. 15-16-17. Formworks for pouring of the vault; preparation in the open, carriage into the tunnel, works in progress.

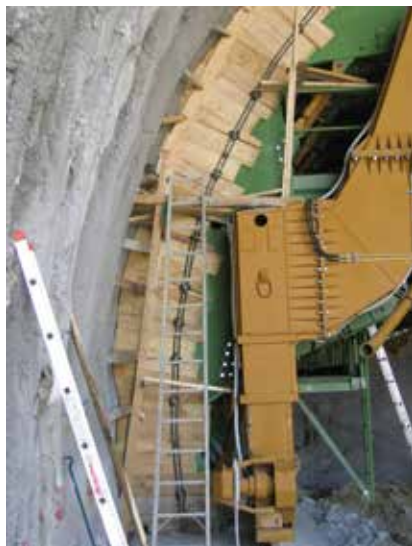
Fig. 18. "Damper" at the end built at the site for perfect adaptation to the profile of the preliminary covering already applied
