# BARRAGE DE PETIT SAUT (GUYANA FRE.)

Treatment of the foundations of dams C and D of the Petit Saut power plant in French Guyana.

April 2000 – January 2001

EDF (Electricité de France)

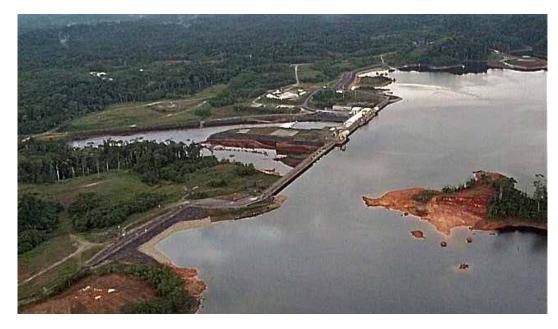
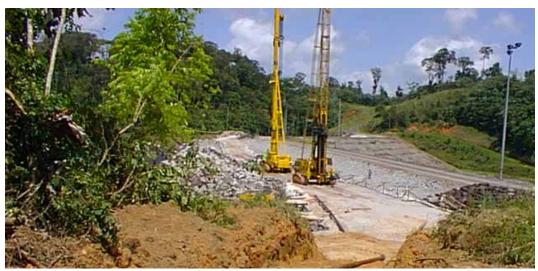
Fig. 1. Aerial view of the Petit Saut dam and, below, view of the probes in the field.

Petit Saut dam (Fig. 1) is a large power plant built by EDF (the French Power Company) in French Guyana, on the Le Sinnamary River. The structure consists of a main dam in concrete, 740 meters long and 47 meters high, and six lesser dams, two of which (A1 and A2) are located on the right bank and four (B, C, D and E) on the left bank. Dams C and D, which were the subject of the works, are respectively 145 and 120 m long and 8 and 15 mt. high. They consist of a uniform nucleus of sandy clay and rest on soil consisting in layers of:

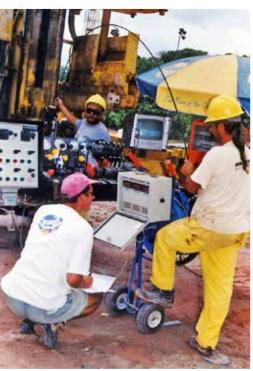
Fig. 4. P 1500 ECS drill rig for Jet Grouting.

Measurement of the deviation from vertical made it possible to improve the injection parameters to produce a column diameters sufficient to guarantee the minimum thickness required of the screen (Fig. 4). After the columns had set and hardened, 16 holes were drilled to control the zones of overlapping between adjacent columns, including 8 with destruction of the nucleus and 8 with continuous core sampling (Fig. 5), that made it possible to verify the quality of the columns.

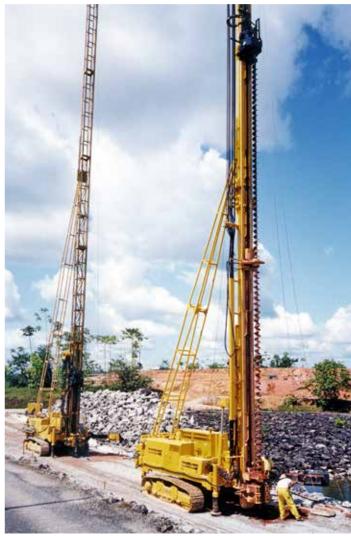
Fig. 5. P 1500 ECS and ES drill rig for core sampling.

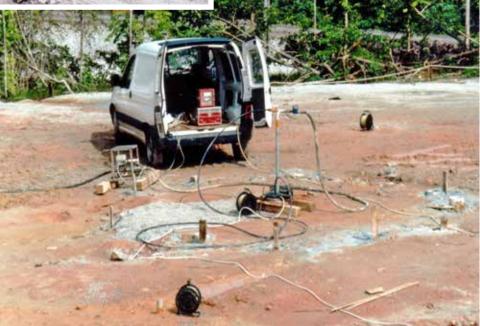
Fig. 6. Pumping test with measurement of the water table level.

Tests of permeability were performed on all the control holes using the Lefranc and Lugeon methods, that gave readings of K < 2x10-7 m/sec. A shaft was also sunk in the field test for a pumping test which lasted 24 hours (Fig. 6). During the first stage of pumping measurements were made of the lowering of the water table level in the shaft; at the same time, the same measurements were made on the two external piezometers. The same measurements repeated during natural restoration of the water table level (subsequent 24 hours) furnished a value of permeability of the screen of K < 2x10-7 m/sec.

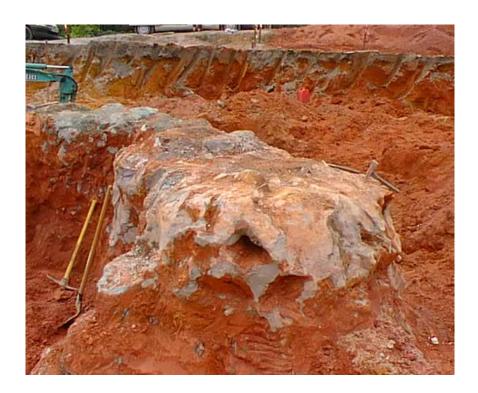
Fig. 7. Column head.

The columns were then excavated (Fig. 7-8), finding that the dimensions varied from a minimum diameter of 135 to a maximum of 180 cm, depending on the injection pa-

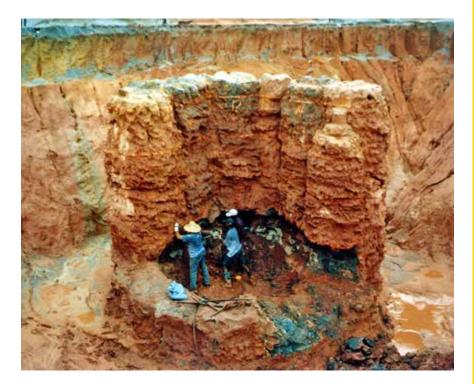
Fig. 8. Excavation of field test columns.

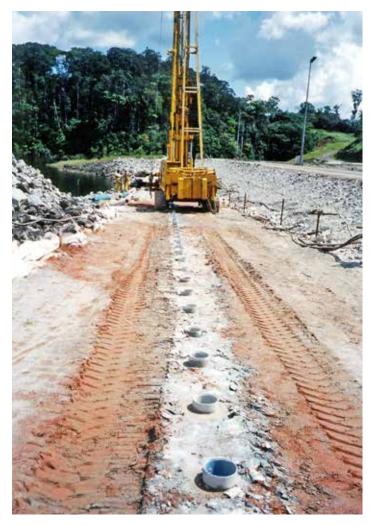
Fig.10. Row of columns.

The entire plan of works was constructed upstream of the crowning of the dams, after removing a section of artificial cliff face in stone. The works provided for construction of a row of columns, with a spacing of 1 m ; crossing the body of the dam to reach the level where the treatment was to start. This was done by dry drilling with the aid of propeller rods. The preliminary hole thus drilled was fitted with a pipe in pvc , sealed at the opening with injections

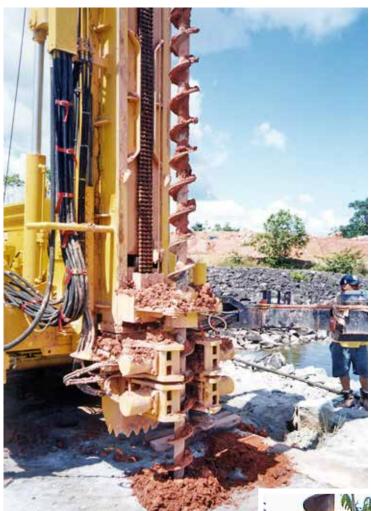
Fig. 11. Perforation using propeller rods to lay piping in pvc.

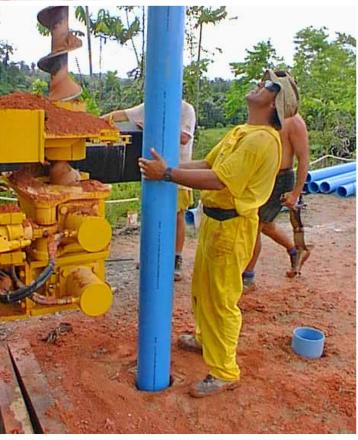
Fig. 12. Laying of pipes in PVC.

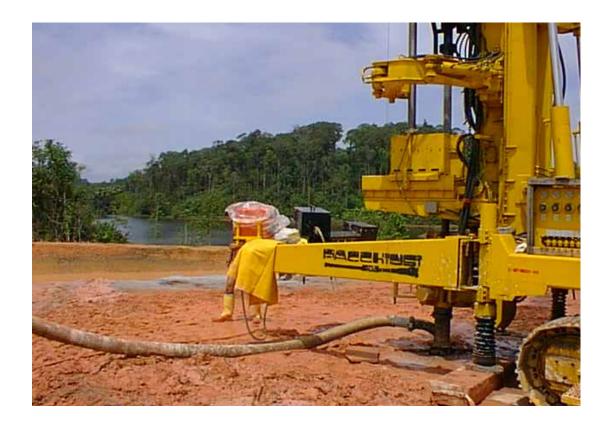
Fig. 13. Recovery of waste fluids.

of slurry so as to eliminate the risk of interference with the draining and monitoring system of the dam. Moreover, to prevent drilling and injection waste fluids from contaminating the waters of the reservoir, a device position at the end of the pipes in pvc intercepted the fluids and conveyed them to a collection zone, far from the reservoir waters (Fig. 13). The maximum deviation of the holes with respect to vertical was below the limit value required by EDF (i.e.1%) of the total drilling length. The injection, made with a mixture of water-cement-bentonite (resistance at 28 days = 5.41 Mpa), made it possible to obtain water columns with a diameter up to 180 cm. During performance of the works, control holes were drilled on 50% of the overlapping zones of the columns. The performance of water tests such as the Lefranc test indicated that, in 95% of the cases, the permeability was below 2x10-7 m/sec and in any case below 5x10-7 m/sec

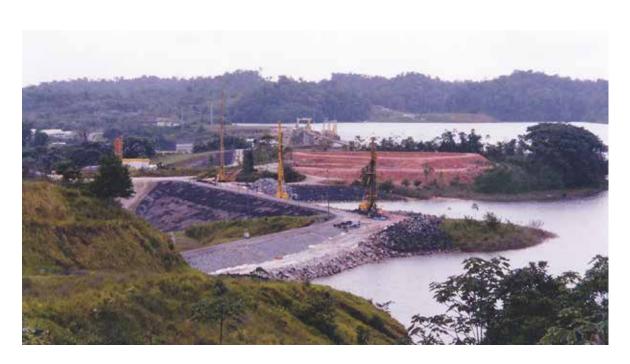
Fig. 16. Probes at work on the dam.

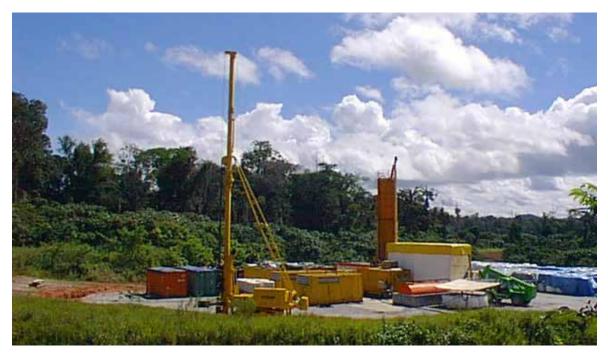
Fig. 17. View of the pumping system.
